# JOINT INVESTIGATION REPORT

INCIDENT NO: 2551773 JIV report S/N: 1030219

1. Fountain Incident Number: 2551773 2. Type of incident: CRUDE OIL SPILL  
3. Name of Location: 4<sup>th</sup> KANBO 3 LIMA RIGHT OF WAY  
EGBEMO ANGALABIRI  
4. Name of nearest community: ANG AGBI DIANA 5. State: BAYELSA 6. LGA: EKEREMO  
7. Type of Production facility/Installation: FLOW LINE  
8. Asset owner/District: THE SHELL PETROLEUM DEVELOPMENT COMPANY OF NIGERIA LIMITED

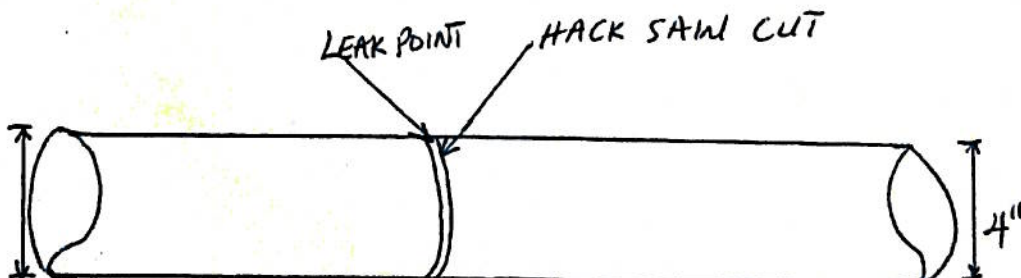
**E. GRAPHIC DESCRIPTION OF LEAK POINT** (while detail report of the leak point should be contained in the leak report, overview sketch of the site should be added as an appendix 1)

A SECTION OF 4" KANBO 3 LIMA AT AGBIDIAMA SHOWING A HACK SAW CUT AT 12 O'CLOCK POSITION.
