JOINT INVESTIGATION REPORT

INCIDENT NO: 2547912 JIV report S/N: 1030239

1. Fountain Incident Number: 2547912 2. Type of incident* OIL SPILL
3. Name of Location 4th UMUECHEM WELL 15S FLOWLINE
4. Name of nearest community UMUECHEM 5. State: RIVERS 6. LGA ETCHE
7. Type of Production facility/Installation FLOWLINE
8. Asset owner/District THE SHELL PETROLEUM DEVELOPMENT COMPANY OF NIGERIA LTD (SPDC)/LAND EAST HUB

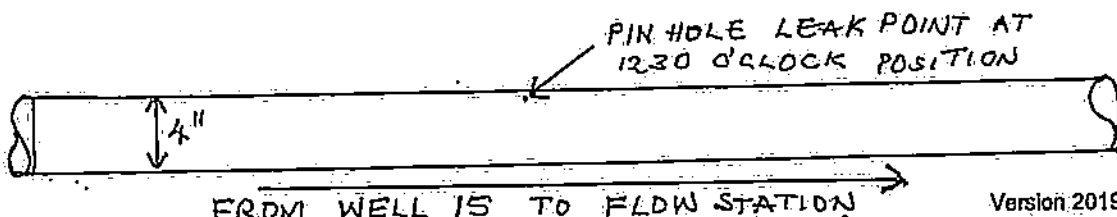
Additional observations around the spill point: THE LEAKING FLOWLINE IS AN UNDERGROUND FACILITY BENEATH THE FLOW STATION CONCRETE PLATFORM.

E. GRAPHIC DESCRIPTION OF LEAK POINT (while detail report of the leak point should be contained in the leak report, overview sketch of the site should be added as an appendix 1) A SECTION OF 4" UMUECHEM WELL IS FLOWLINE AT UMUECHEM SHOWING A PIN HOLE LEAK POINT AT 1230 O'CLOCK POSITION DUE TO CORROSION.

SECTIONAL REPLACEMENT
