# JOINT INVESTIGATION REPORT

INCIDENT NO: 2679887 JIV report S/N:

1. Fountain Incident Number: 2679887 2. Type of incident\* OIL SPILL  
3. Name of Location 12" IMO RIVER 1 - OGALE PIPELINE  
4. Name of nearest community UMUOLOLO 5. State: ABIA 6. LGA UKWA WEST  
7. Production Facility/Installation OIL PIPELINE  
8. Asset Owner/Hub THE SHELL PETROLEUM DEVELOPMENT COMPANY OF NIGERIA LIMITED (SPDC)/PIPELINE

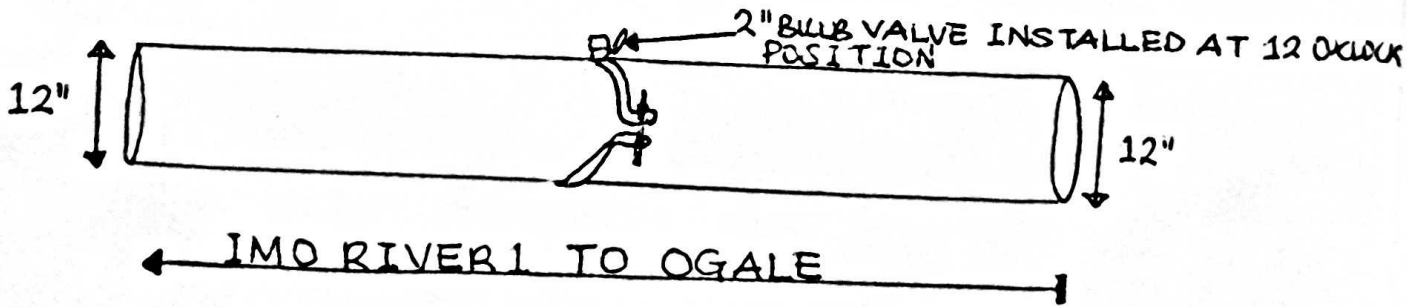
E. GRAPHIC DESCRIPTION OF LEAK POINT (while detailed description of the leak point should be contained in the leak report, overview sketch of the site should be added as appendix 1)

| <input checked="" type="checkbox"/> Crude oil theft (illegal bunkering) point, | <input type="checkbox"/> Saver-pit over flow | <input type="checkbox"/> Third party tampering with Clamp |

A SECTION OF 12" IMO RIVER 1 - OGALE PIPELINE AT UMUOLOLO SHOWING 2" BULB VALVE INSTALLED AT A 12 O'CLOCK POSITION BY UNKNOWN PERSON(S)

SPILL RECOVERY/REPAIRS BY CLAMPING
