Overview: Part of spill impact on on 12" Oguta Assa Pipeline at Opuoma . Picture was taken during Joint Investigation 15th July 2020.

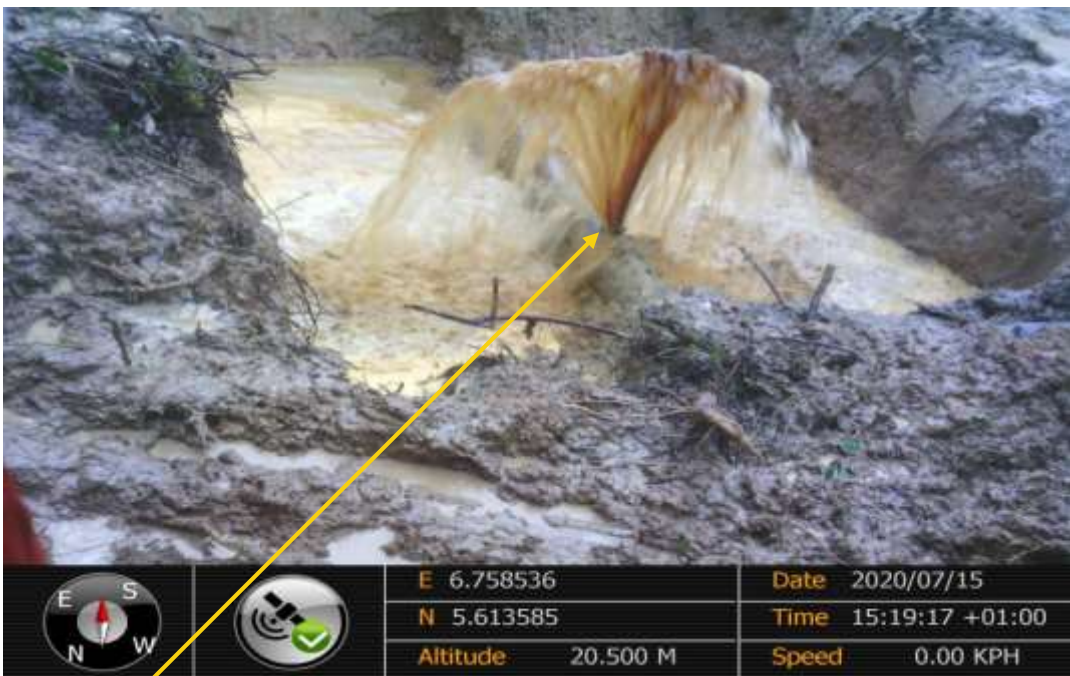
Close-up: 4inch valve installed at 12 o'clock position on 12" Oguta Assa Pipeline at Opuoma Picture was taken during Joint Investigation 15th July 2020.
