# JOINT INVESTIGATION REPORT

INCIDENT NO: 2685785 JIV report S/N: 0572

1. Foremost Incident Number 2685785 2. Type of incident\* OIL SPILL  
3. Name of Location 12" OGUTA - ASSA PIPELINE  
4. Name of nearest community OPUOMA 5. State: IMO 6. LGA EGBENIA  
7. Production Facility/Installation CRUDE OIL PIPELINE  
8. Asset Owner/Hub THE SHELL PETROLEUM DEVELOPMENT COMPANY OF NIGERIA LIMITED (SPDC)/PIPELINE

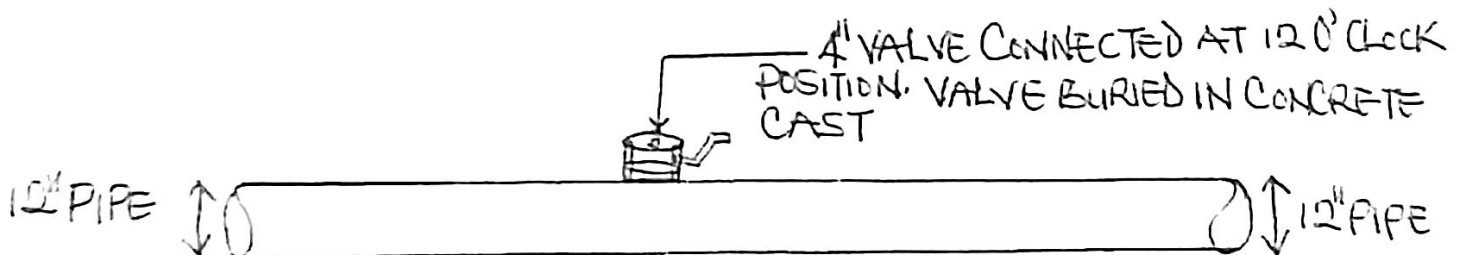
**E. GRAPHIC DESCRIPTION OF LEAK POINT** (while detailed description of the leak point should be contained in the leak report, overview sketch of the site should be added as appendix.)

A SECTION OF 12" OGITA -  
 SSA PIPELINE AT (PUDMA) SHOWING 4" VALVE (INSTALLED) AT 12 O' CLOCK  
 POSITION BY UNKNOWN PERSON(S).

CLAMPING
