# JOINT INVESTIGATION REPORT

INCIDENT NO: 2694542 JIV report S/N:

1. Fountain Incident Number: 2694542 2. Type of incident\* OIL SPILL  
3. Name of Location 4" IMO RIVER WELL 32 L FLOWLINE  
4. Name of nearest community IGIRIUKWU 5. State: ABIA 6. LGA UKWA WEST  
7. Production Facility/Installation CRUDE OIL FLOWLINE  
8. Asset Owner/Hub THE SHELL PETROLEUM DEVELOPMENT COMPANY  
OF NIGERIA LIMITED / LAND EAST HUB

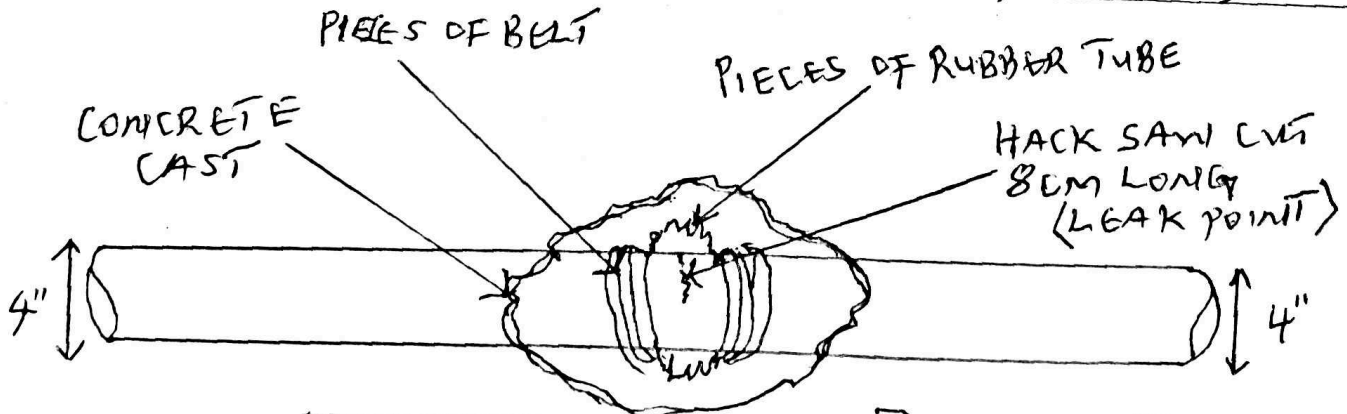
**E. GRAPHIC DESCRIPTION OF LEAK POINT** (while detailed description of the leak point should be contained in the leak report, overview sketch of the site should be added as appendix 1)

CONCRETE CAST, PIECE OF RUBBER TUBE AND BELT ARE USED TO CONCEAL THE LEAK POINT.

| <input type="checkbox"/> Smooth round-edge hole | <input type="checkbox"/> Rough-edge hole | <input checked="" type="checkbox"/> Hack saw cut |

SECTION OF 4" IMO RIVER WELL 32 L FLOWLINE AT IGIRUKWU OYAZA SHOWING A HACK SAW CUT FROM 12 O'CLOCK TO 2 O'CLOCK POSITION BY UNKNOWN PERSON(S).

FROM IMO RIVER WELL 32 L TO FLOW STATION
