# JOINT INVESTIGATION REPORT

INCIDENT NO: 2684812 JIV report S/N: 0643

1. Fountain Incident Number: 2684812 2. Type of incident\* OIL SPILL  
3. Name of Location 14" OKORDIA - RUMUEKPE PIPELINE  
4. Name of nearest community UKPELEDE 5. State: RIVERS 6. LGA AHOADA WEST  
7. Production Facility/Installation CRUDE OIL PIPELINE  
8. Asset Owner/Hub THE SHELL PETROLEUM DEVELOPMENT COMPANY OF NIGERIA LIMITED / PIPELINE

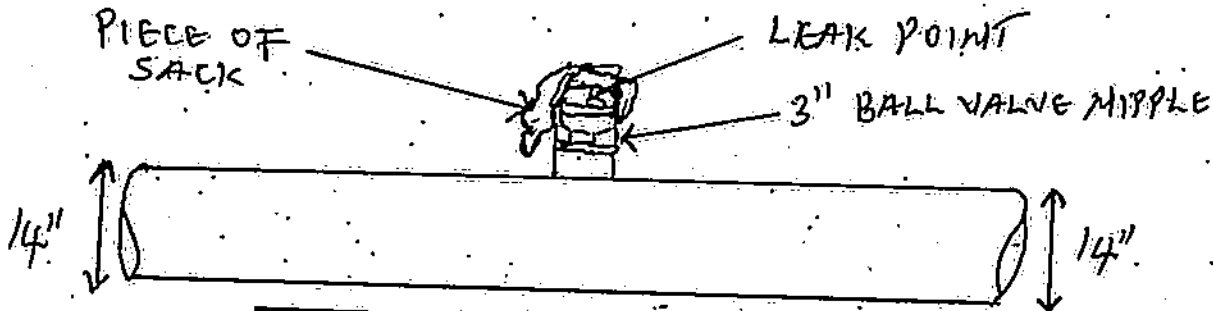
**E. GRAPHIC DESCRIPTION OF LEAK POINT** (while detailed description of the leak point should be contained in the leak report, overview sketch of the site should be added as appendix 1)

SECTION OF 14" OKORDIA - RUMUEKPE PIPELINE AS UNDETECTED SHOWING CRUDE OIL THEFT POINT INSTALLED AT 12 O'CLOCK POSITION BY UNKNOWN PERSONS.

FROM OKORDIA TO RUMUEKPE
