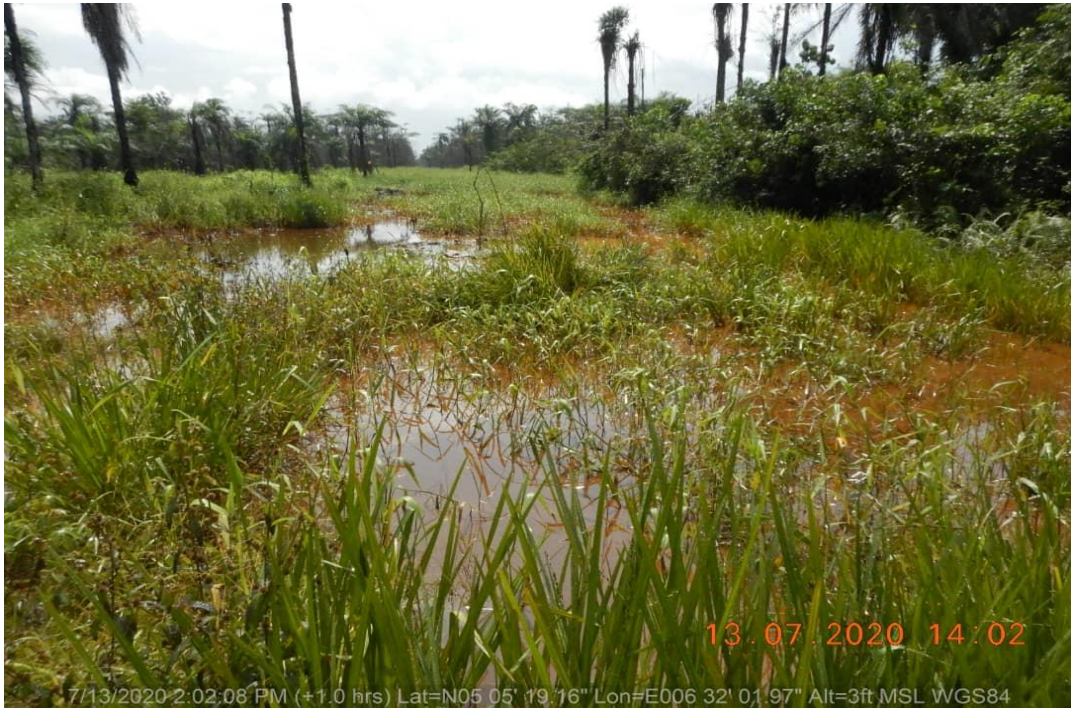
Overview: Part of spill impact on 14" Okordia - Rumuekpe Pipeline at Ukpeliède. Picture was taken during Joint Investigation on 13th July 2020.

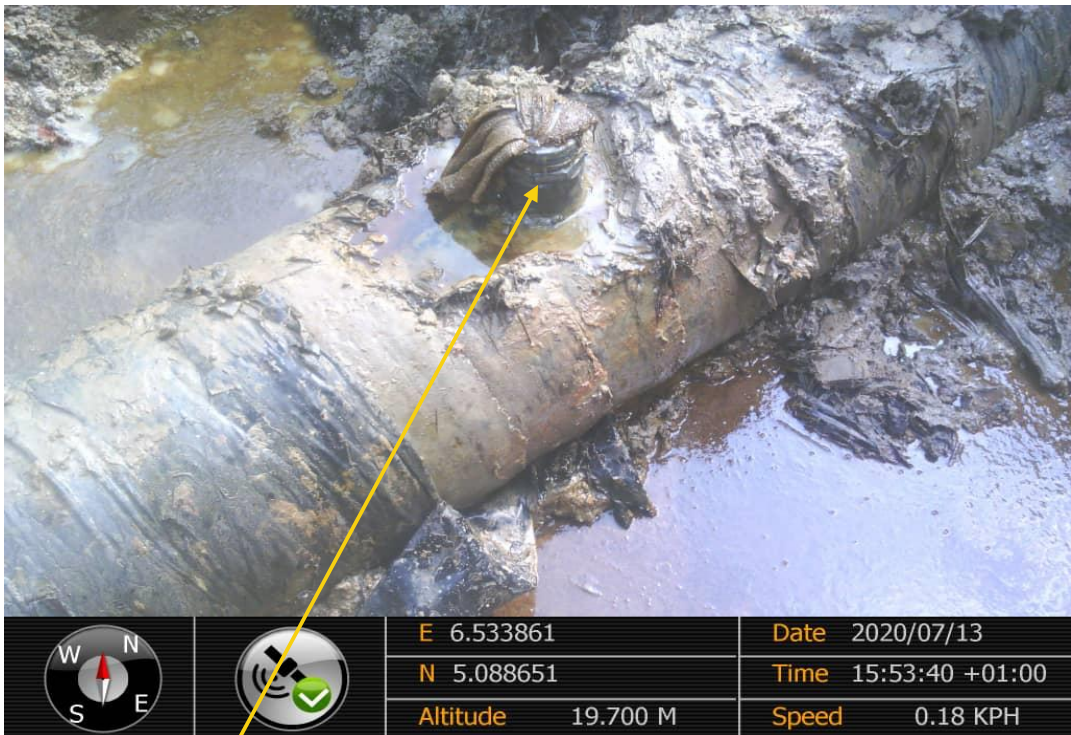
Close-up: Crude oil theft point installed at 12 o'clock position on 14" Okordia Rumuekpe Pipeline at Ukpeliède. Picture was taken during Joint Investigation on 13th July 2020.
