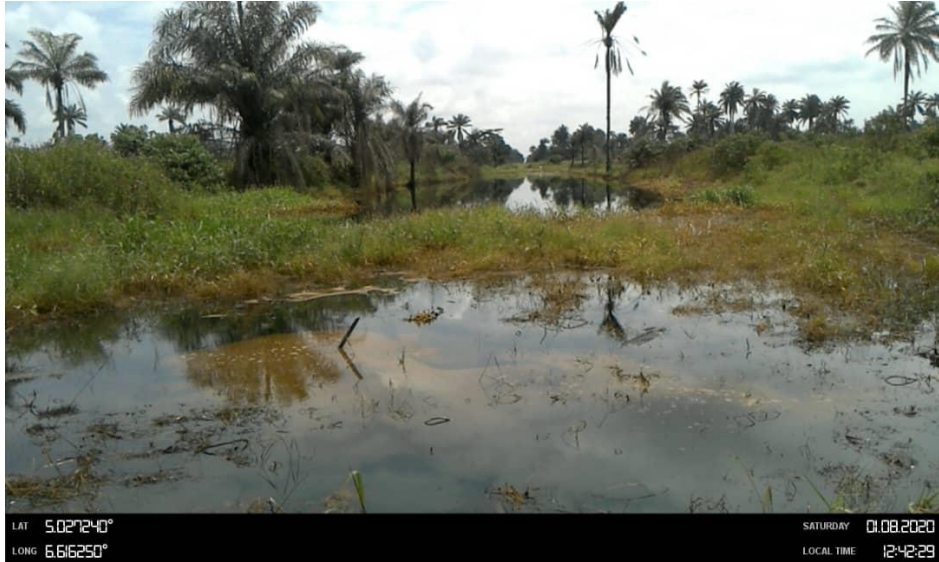
Overview: Part of spill impact on 14" Okordia - Rumuekpe Pipeline at Edeoha. Picture was taken during Joint Investigation of 1st Aug 2020.

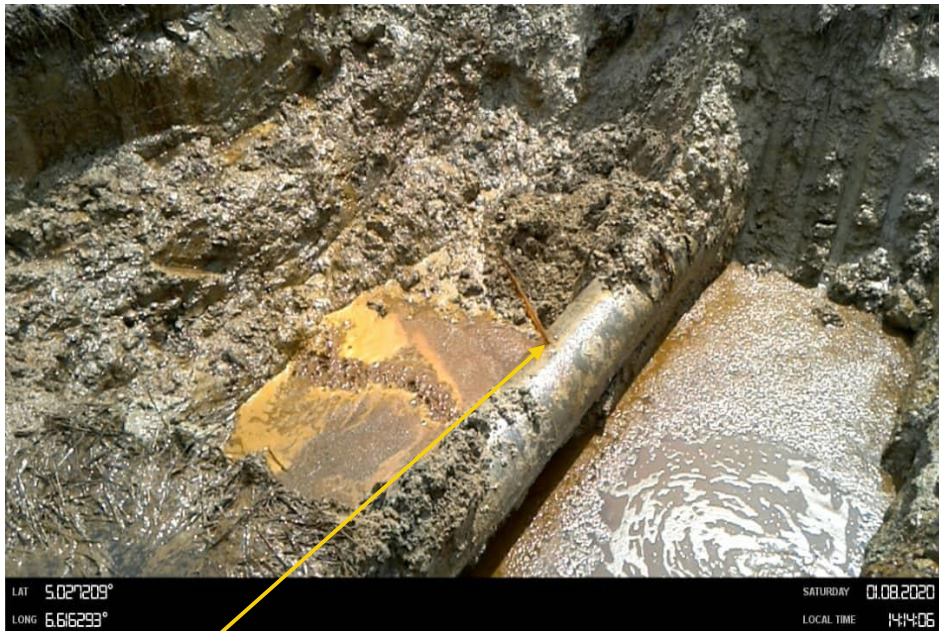
Close-up: 15mm drilled hole installed at 12:15 o'clock position on 14" Okordia - Rumuekpe Pipeline at Edeoha. Picture was taken during Joint Investigation of 1st Aug 2020.
