# JOINT INVESTIGATION REPORT

INCIDENT NO: 2684795 JIV report S/N: 0571

1. Fountain Incident Number: 2684795 2. Type of incident\* OIL SPILL/FIRE  
3. Name of Location 18" ASSA-RUMUEKPE PIPELINE  
4. Name of nearest community AWARA 5. State: IMO 6. LGA OHATI-EGBEMA  
7. Production Facility/Installation CRUDE OIL PIPELINE  
8. Asset Owner/Hub THE SHELL PETROLEUM DEVELOPMENT COMPANY

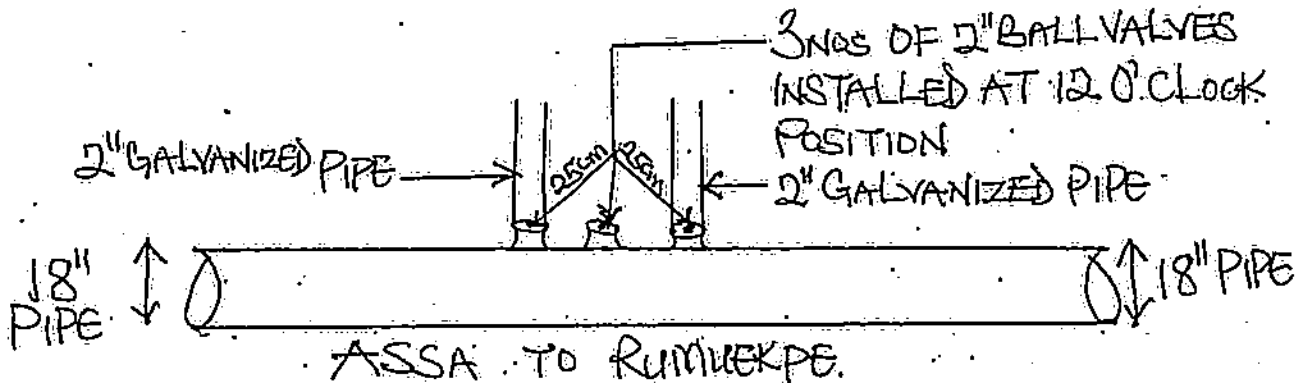
BURNT CARBONIZED SOIL

| <input checked="" type="checkbox"/> Crude oil theft (illegal bunkering) point, | <input type="checkbox"/> Saver-pit over flow | <input type="checkbox"/> Third party tampering with Clamp |

**E. GRAPHIC DESCRIPTION OF LEAK POINT** (while detailed description of the leak point should be contained in the leak report, overview sketch of the site should be added as appendix 1) A SECTION OF 18" ASSA - RUMUEKPE PIPELINE AT ANARA SHOWING 3 NOS OF 2" BALL VALVE INSTALLED AT 12 O'CLOCK POSITION BY UNKNOWN PERSON(S).

CLAMPING
