# JOINT INVESTIGATION REPORT

INCIDENT NO: 2661031 JIV report S/N:

1. Fountain Incident Number: 2661031 2. Type of incident\* OIL SPILL  
3. Name of Location 12" IMO RIVER - OGALE PIPELINE  
4. Name of nearest community UMUOLOLO 5. State: ABIA 6. LGA UKWA WEST  
7. Production Facility/Installation OIL PIPELINE  
8. Asset Owner/Hub THE SHELL PETROLEUM DEVELOPMENT COMPANY OF NIGERIA LIMITED (SPDC) / PIPELINE

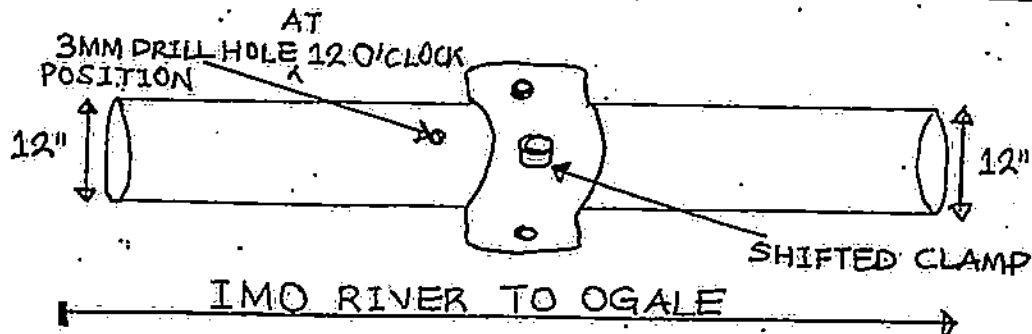
**E. GRAPHIC DESCRIPTION OF LEAK POINT** (while detailed description of the leak point should be contained in the leak report, overview sketch of the site should be added as appendix 1)

A SECTION OF 12" IMO RIVER - OGALE PIPELINE AT UMUOLOLD SHOWING A 3MM DRILLED HOLE AT 12 O'CLOCK POSITION BY UNKNOWN PERSON(S).

SPILL RECOVERY / REPAIRS BY CLAMPING
