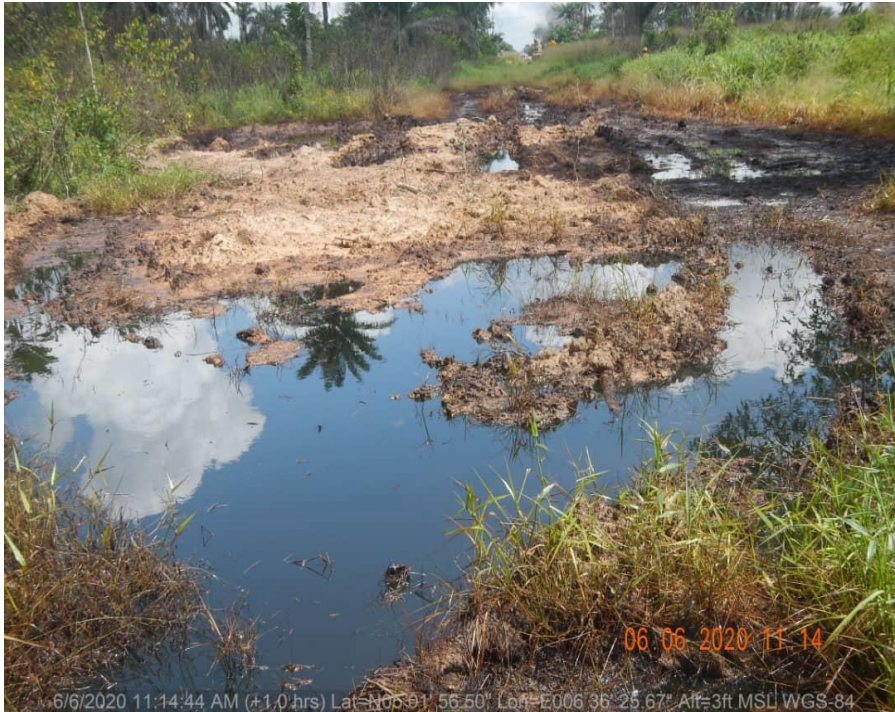
Overview: Part of spill impact on 14" Okordia - Rumuekpe Pipeline at Edeoha. Picture was taken during Joint Investigation of 6th June 2020.

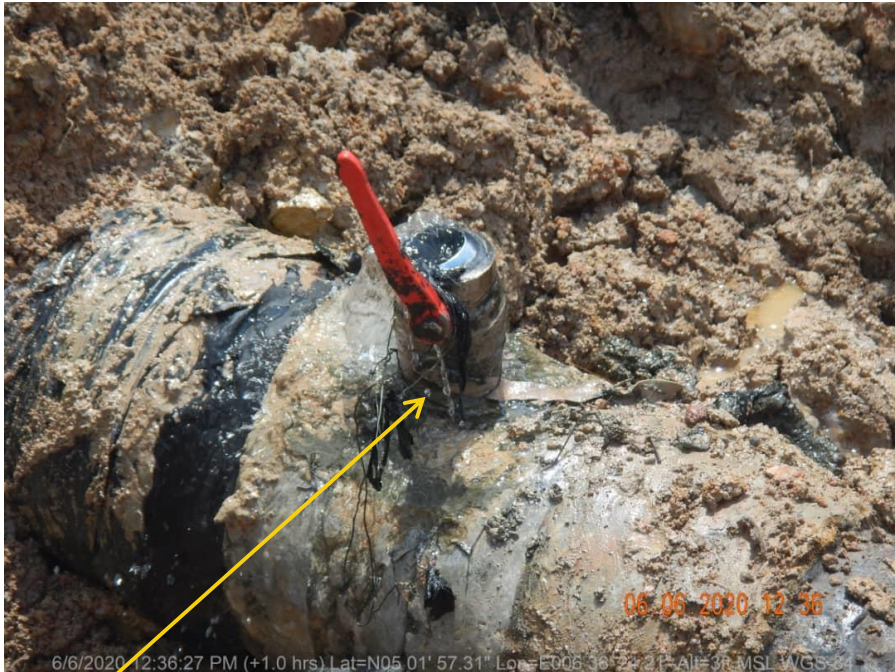
Close-up: Crude oil theft point installed at 12 o'clock position on 14" Okordia - Rumuekpe Pipeline at Edeoha. Picture was taken during Joint Investigation of 6th June 2020
