# JOINT INVESTIGATION REPORT

INCIDENT NO: 2662361 JIV report S/N: 0543

1. Fountain Incident Number: 2662361 2. Type of incident\* OIL SPILL  
3. Name of Location 28" BONNY-BONNY PIPELINE  
4. Name of nearest community KPOR 5. State: RIVERS 6. LGA GOKANA  
7. Production Facility/Installation CRUDE OIL PIPELINE  
8. Asset Owner/Hub THE SHELL PETROLEUM DEVELOPMENT COMPANY OF NIGERIA LIMITED (SPDC)/PIPELINE

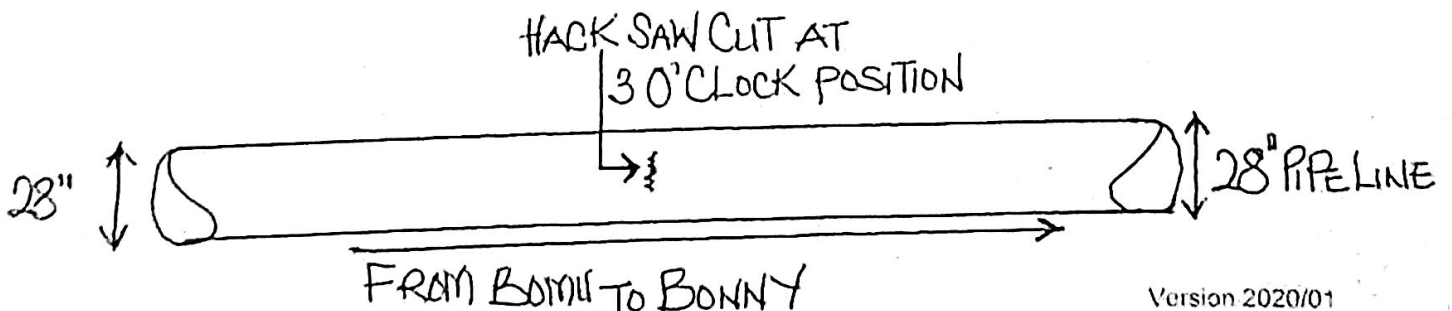
E. GRAPHIC DESCRIPTION OF LEAK POINT (while detailed description of the leak point should be contained in the leak report, overview sketch of the site should be added as appendix 1) A SECTION OF 28" BOMU-BONNY PIPELINE AT KPOR SHOWING A HACK SAW CUT OF 4cm LENGTH AT 3 O'CLOCK POSITION BY UNKNOWN PERSON(S).

CLAMPING AND OIL SPILL RESPONSE
