Overview: Part of spill impact on 14" Okordia Rumuekpe Pipeline at Ula-Okobo. Picture was taken during Joint Investigation 19th June 2020.

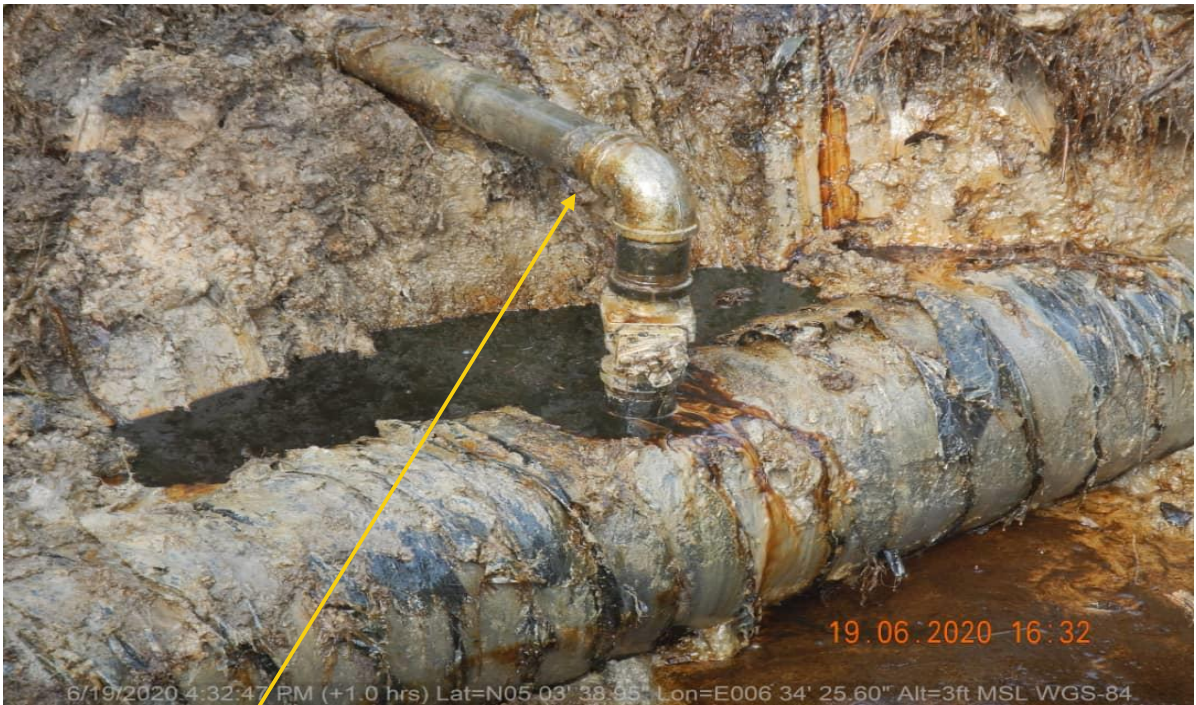
Closeup 1: Crude Oil theft point installed at 12 o'clock position on 14" Okordia Rumuekpe Pipeline at Ula-Okobo. Picture was taken during Joint Investigation 19th June 2020.

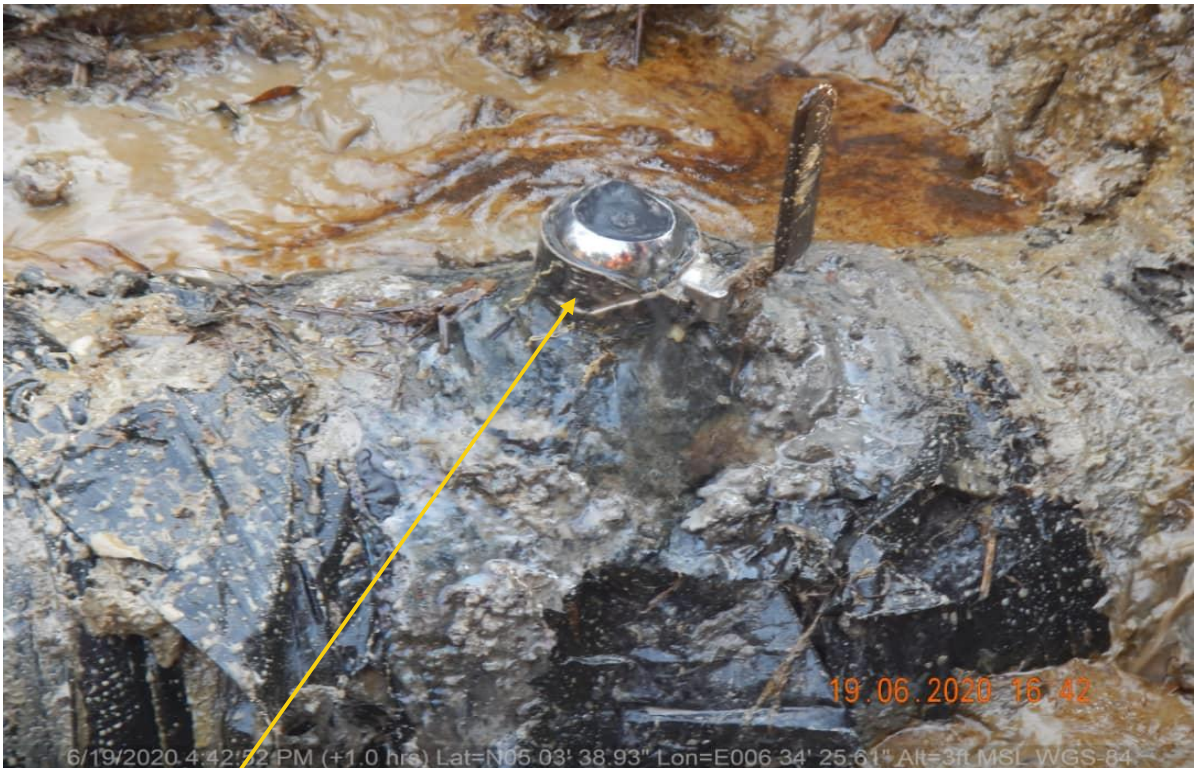
Close-up 2: Crude Oil theft point installed at 12 o'clock position on 14" Okordia Rumuekpe Pipeline at Ula-Okobo. Picture was taken during Joint Investigation 19th June 2020.
