JOINT INVESTIGATION REPORT

INCIDENT NO: 2677078 JIV report S/N: 0636

1. Fountain Incident Number: 2677078 2. Type of incident* OIL SPILL
3. Name of Location 12" IMO RIVER - OGALE PIPELINE
4. Name of nearest community UMUOLOLO 5. State: ABIA 6. LGA UKWA WEST
7. Production Facility/Installation OIL PIPELINE
8. Asset Owner/Hub THE SHELL PETROLEUM DEVELOPMENT COMPANY OF NIGERIA LIMITED (SPDC)/PIPELINE

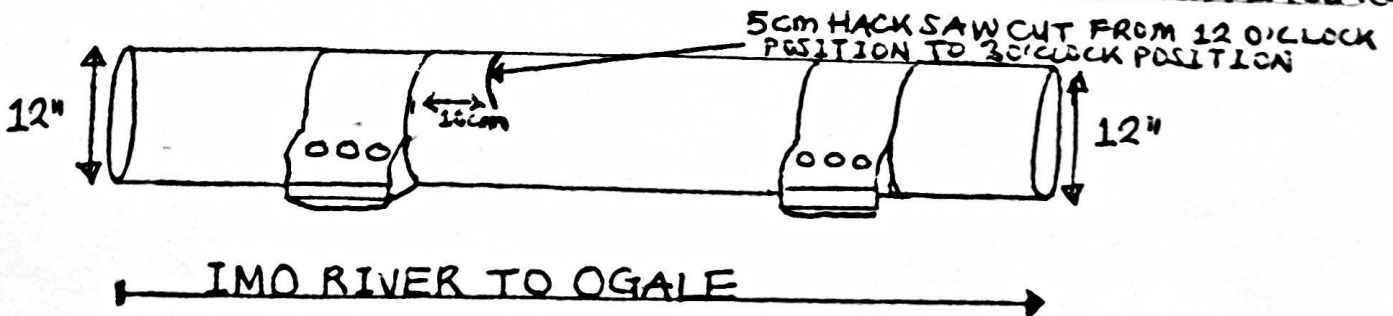
E. GRAPHIC DESCRIPTION OF LEAK POINT (while detailed description of the leak point should be contained in the leak report, overview sketch of the site should be added as appendix 1)

A SECTION OF 12" IMO RIVER - OGALE PIPELINE SHOWING A 5cm HACK SAW CUT FROM A 12 O'CLOCK POSITION TO A 3 O'CLOCK POSITION BY UNKNOWN PERSON(S)

REPAIRS BY CLAMING^P
