Overview: Part of spill impact on 12" ImoRiver - Ogale Pipeline at Umulolo. Picture was taken during Joint Investigation 1st July 2020.

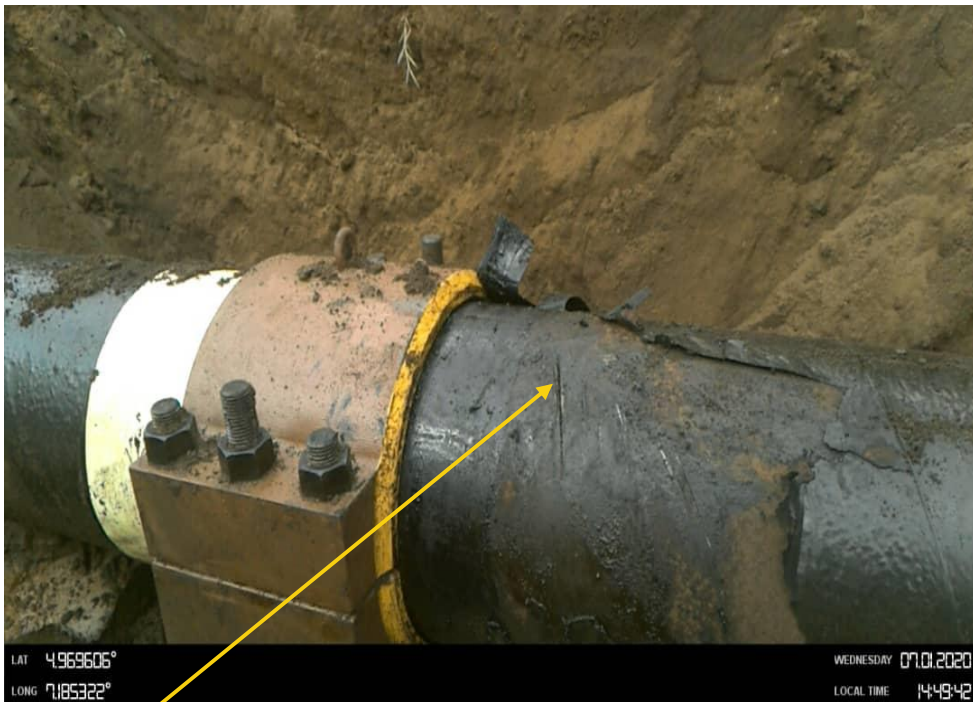
Close-up: 5cm Hacksaw cut from a 12 o'clock to 3 o'clock position on 12" ImoRiver - Ogale Pipeline at Umulolo. Picture was taken during Joint Investigation 1st July 2020.
