Overview: Part of spill impact on 4" Imo River 2\_ImoRiver 1 Bulkline at Odagwa. Picture was taken during Joint Investigation 30th June 2020.

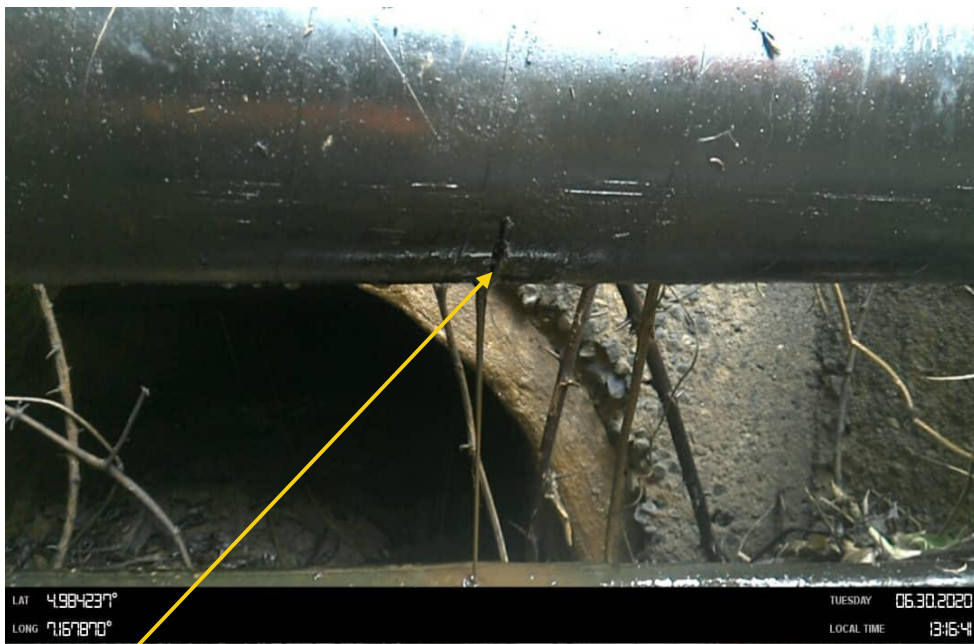
Close-up: 7cm hacksaw cut from 8 o'clock position to a 6 o'clock position on 4" Imo River 2\_ImoRiver 1 Bulkline at Odagwa. Picture was taken during Joint Investigation 30th June 2020.
