JOINT INVESTIGATION REPORT

INCIDENT NO: 2674677 JIV report S/N: 0635

1. Fountain Incident Number: 2674677 2. Type of incident* OIL SPILL
3. Name of Location ^{4"} IMO RIVER 2 TO IMO RIVER 1 BULKLINE
4. Name of nearest community ODAGWA 5. State: RIVERS 6. LGA ETCHE
7. Production Facility/Installation BULKLINE
8. Asset Owner/Hub THE SHELL PETROLEUM DEVELOPMENT COMPANY OF NIGERIA LIMITED (SPDC) / LAND EAST HUB

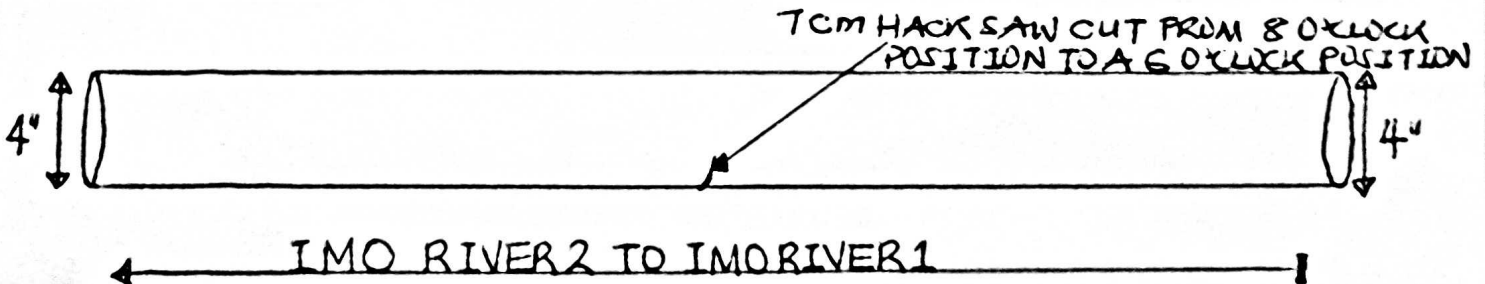
| <input type="checkbox"/> Smooth round-edge hole | <input type="checkbox"/> Rough-edge hole | <input checked="" type="checkbox"/> Hack saw cut |

A SECTION OF 4" IMO RIVER 2 - IMO RIVER 1
BULKLINE AT ODAGWA SHOWING A 7CM HACK SAW CUT
FROM 8 O'CLOCK POSITION TO A 6 O'CLOCK POSITION BY UNKNOWN
PERSON(S)

REPAIRS BY SECTIONAL REPLACEMENT
