JOINT INVESTIGATION REPORT

INCIDENT NO: 2603960 JIV report S/N: 0568

1. Fountain Incident Number: 2603960 2. Type of incident* OIL SPILL
3. Name of Location 20" Kolo Creek Trunkline at Okporowo
4. Name of nearest community OKPOROWO 5. State: RIVERS 6. LGA AITOADA EAST
7. Production Facility/Installation OIL PIPELINE
8. Asset Owner/Hub THE SHELL PETROLEUM DEVELOPMENT COMPANY OF NIGERIA LIMITED (SPDC) / PIPELINE

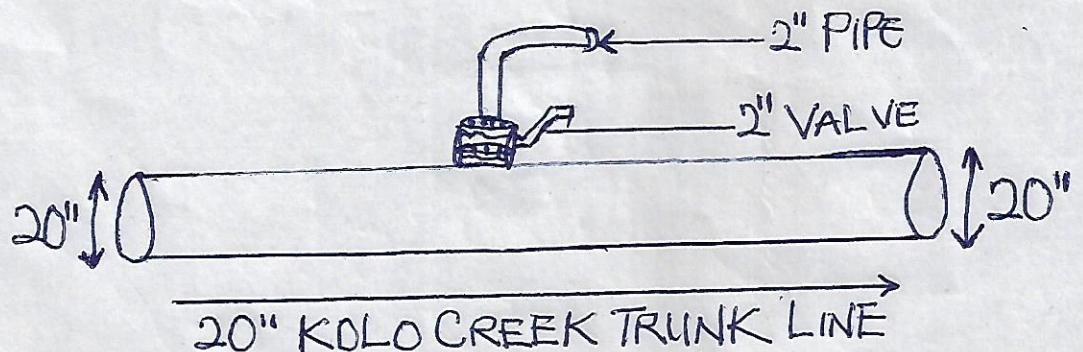
E. GRAPHIC DESCRIPTION OF LEAK POINT (while detailed description of the leak point should be contained in the leak report, overview sketch of the site should be added as appendix 1) A SECTION OF 20" KOLO CREEK TRUNK LINE AT OKPOROW SHOWING A 2" VALVE INSTALLED ON 12 O'CLOCK POSITION BY UNKNOWN PERSON(S).

CLAMPING/SPILL RESPONSE IN PROGRESS
