JOINT INVESTIGATION REPORT

INCIDENT NO: 2611431 JIV report S/N:

- 1. Fountain Incident Number: 2611431 2. Type of incident* OIL SPILL
- 3. Name of Location 28" NKPOKU-BOMU PIPELINE AT ETEO
- 4. Name of nearest community ETEO 5. State: RIVERS 6. LGA _____
- 7. Production Facility/Installation CRUDE OIL PIPELINE
- 8. Asset Owner/Hub THE SHELL PETROLEUM DEVELOPMENT COMPANY OF NIGERIA LIMITED (SPDC)/PIPELINE

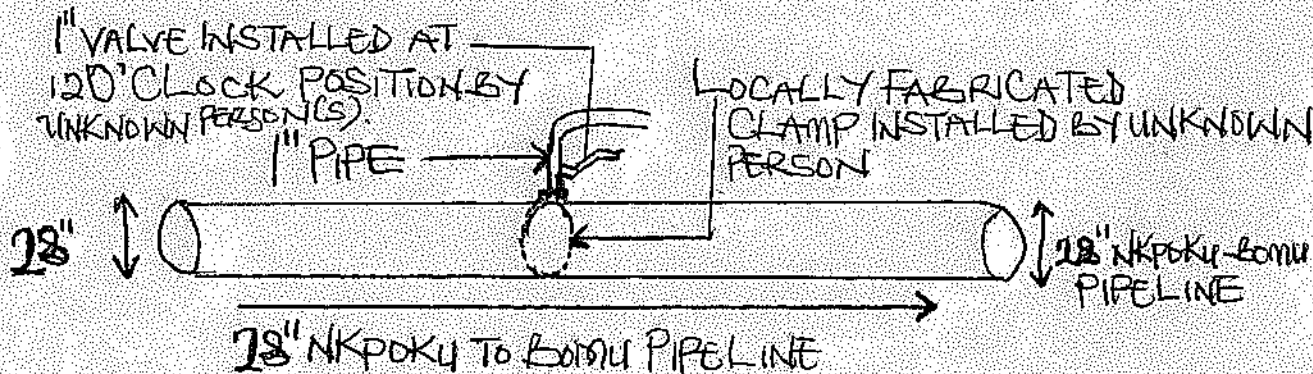
E. GRAPHIC DESCRIPTION OF LEAK POINT (while detailed description of the leak point should be contained in the leak report, overview sketch of the site should be added as appendix 1) A SECTION OF 28" NKPOKU-BOMU PIPELINE AT ETEO SHOWING A LOCALLY FABRICATED CLAMP WITH ONE (1") VALVE INSTALLED AT 12 O'CLOCK POSITION BY UNKNOWN PERSON(S).

CLAMPING INITIATED AND SPILL RESPONSE ONGOING
