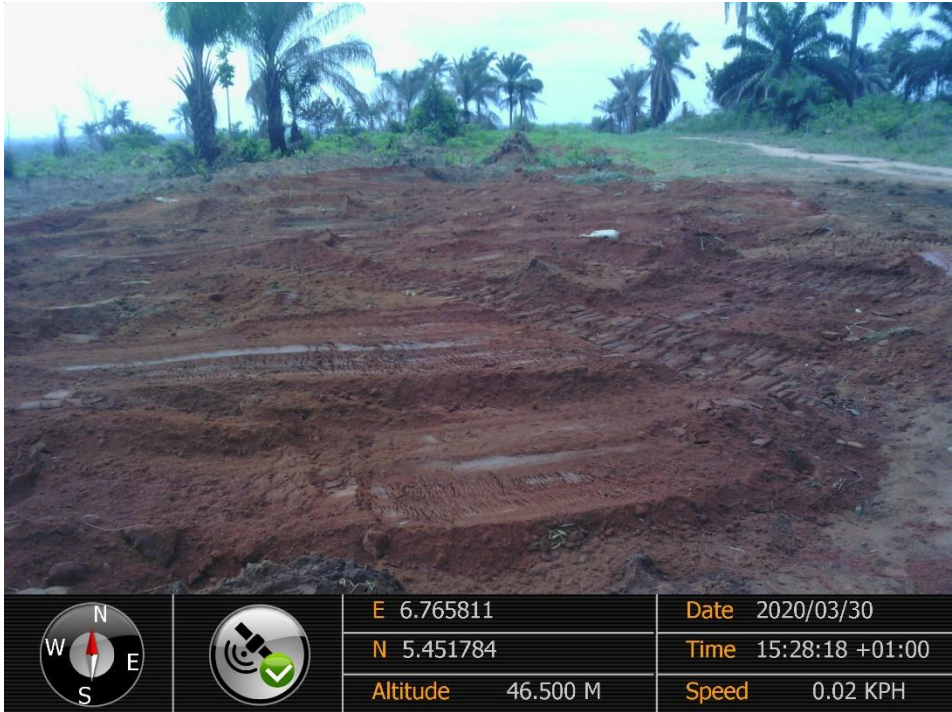
Overview: Part of spill impact on 16" Egbema Assa Pipeline at Umudike. Picture was taken during Joint Investigation of 30th March 2020.

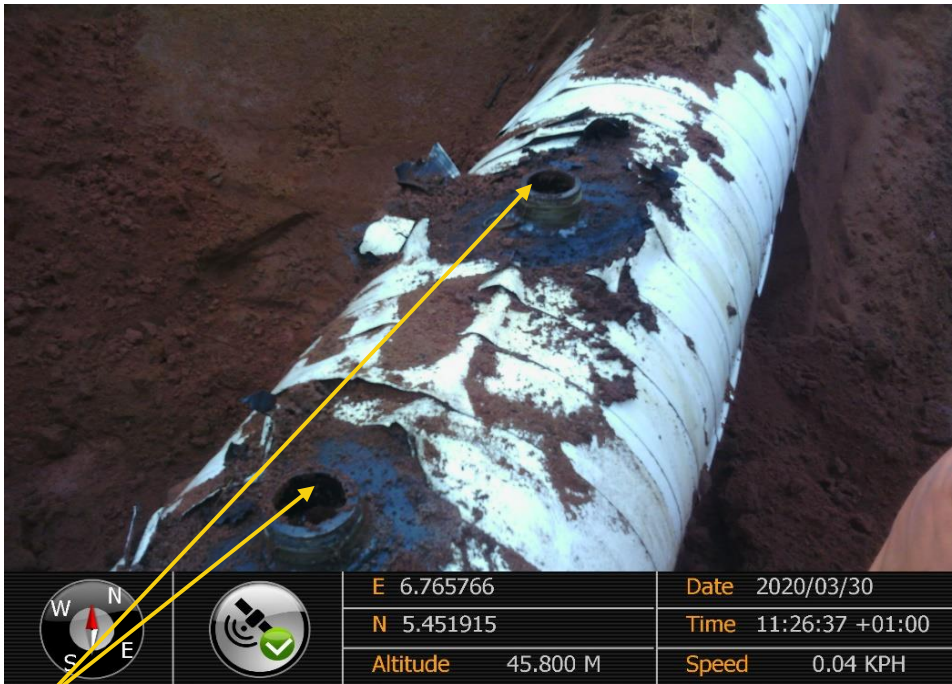
Close-up: 2nos 2" nipple (0.5m apart) installed at 12 o'clock position on 16" Egbema - Assa Pipeline at Umudike. Picture was taken during Joint Investigation of 30th March 2020.
