JOINT INVESTIGATION REPORT

INCIDENT NO: 2616750 JIV report S/N:

1. Fountain Incident Number: 2616750 2. Type of incident* OIL SPILL
3. Name of Location 14" OKORDIA - RUMUEKPE PIPELINE
4. Name of nearest community AKINJIMA 5. State: RIVERS 6. LGA AHOADA WEST
7. Production Facility/Installation OIL PIPELINE
8. Asset Owner/Hub THE SHELL PETROLEUM DEVELOPMENT COMPANY OF NIGERIA LTD (SPDC) / PIPELINE

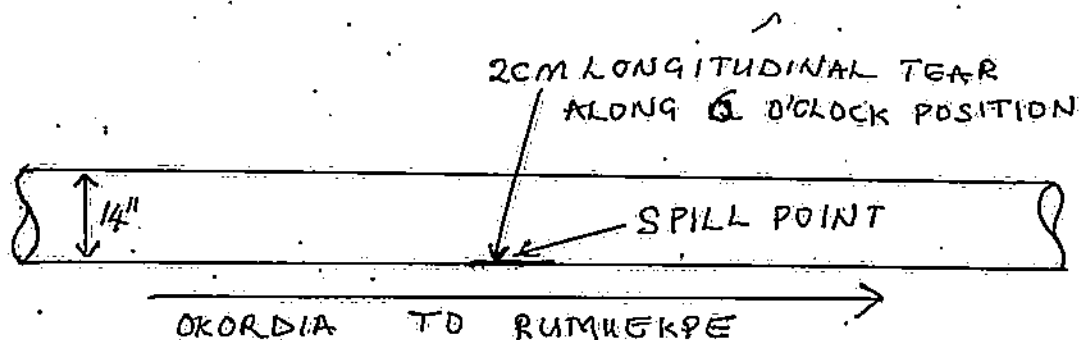
| <input checked="" type="checkbox"/> Tear (<u>LONGITUDINAL</u>) | | |

E. GRAPHIC DESCRIPTION OF LEAK POINT (while detailed description of the leak point should be contained in the leak report, overview sketch of the site should be added as appendix 1) A SECTION OF 14" OKORDIA - RUMUEKPE PIPELINE AT AKINIMA SHOWING 2CM LONGITUDINAL TEAR ALONG 6 O'CLOCK POSITION DUE TO EQUIPMENT FAILURE.

SPILL RECOVERY / REPAIR BY CLAMPING
