JOINT INVESTIGATION REPORT

INCIDENT NO: 2601407 JIV report S/N: 0567

1. Fountain Incident Number: 2601407 2. Type of incident* OIL SPILL
3. Name of Location 12" Imo River 2 - OGALE PIPELINE AT UMUOLOLO
4. Name of nearest community UMUOLOLO 5. State: ABIA 6. LGA UKWA WEST
7. Production Facility/Installation PIPELINE
8. Asset Owner/Hub THE STEEL PETROLEUM DEVELOPMENT COMPANY OF NIGERIA LIMITED (SPDC) / PIPELINE

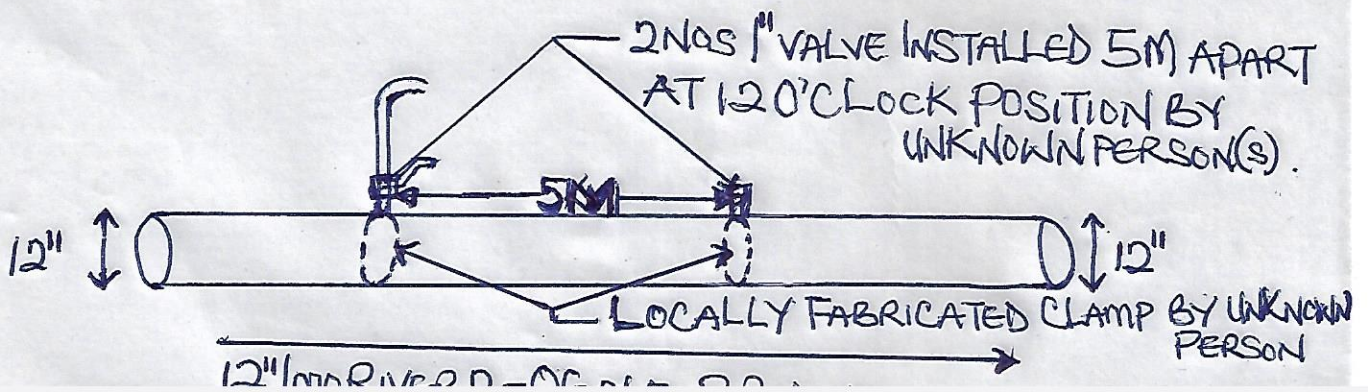
| <input checked="" type="checkbox"/> Crude oil theft (illegal bunkering) point, | <input type="checkbox"/> Saver-pit over flow | <input type="checkbox"/> Third party tampering with Clamp |

E. GRAPHIC DESCRIPTION OF LEAK POINT (while detailed description of the leak point should be contained in the leak report, overview sketch of the site should be added as appendix 1) A SECTION OF 12" IMD RIVER 2-OGALE PIPELINE AT UMUOLOLO SHOWING TWO (2) NOS 1" VALVE INSTALLED 5M APART AT 12 O'CLOCK POSITION BY UNKNOWN PERSON(S)

CLAMPING ONGOING AND SPILL RESPONSE
