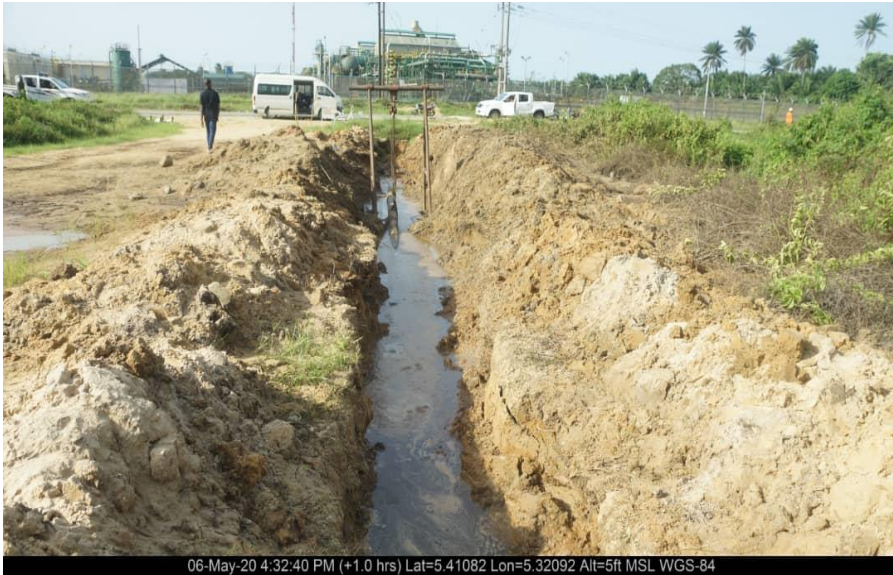
Overview: Part of spill impact on 6" North bank central processing facility condensate delivery line at Obotobo. Picture was taken during Joint Investigation of 6th May 2020.

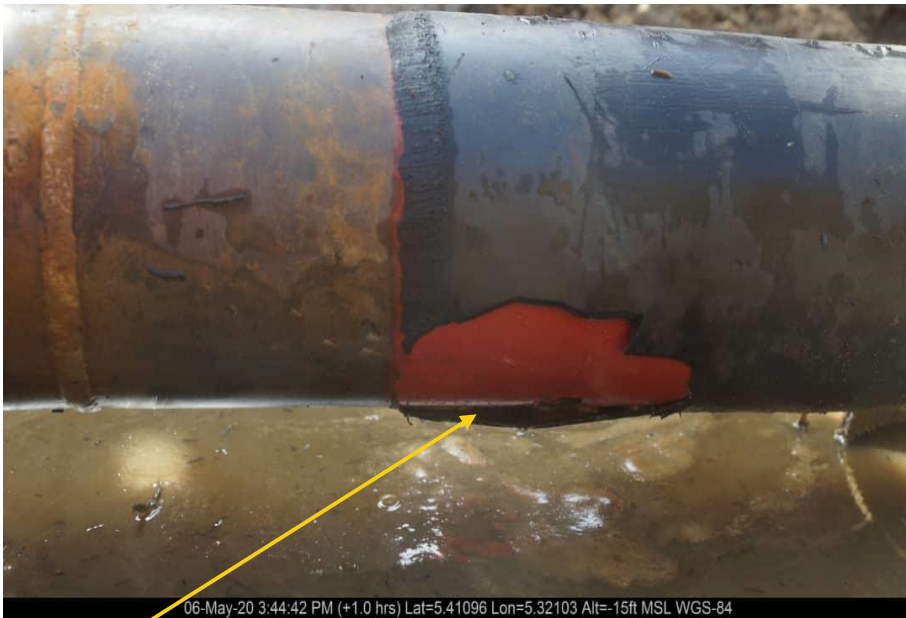
Close-up: Irregular hole at 7 o'clock position on 6" North bank central processing facility condensate delivery line at Obotobo. Picture was taken during Joint Investigation of 6th May 2020.
