INCIDENT NO: 2637463 JIV report S/N: 0508

A. GENERAL INFORMATION:					
Fountain Incident Number: 2637403 2. Type of incident* OIL SPILI					
3. Name of Location 28" NKPOKu - P	3. Name of Location 28" NKPOKU-BOMU PIPELINE AT B-DERE				
		S G. LGA GOKHANA

7. Production Facility/Installation CRUD	e oil Pif	PELINE			
8. Asset Owner/Hub Itte Stell PE	8. ASSCI OWNER/HUD THE SHELL PETROLEUM DEVELOPMENT COMPANY

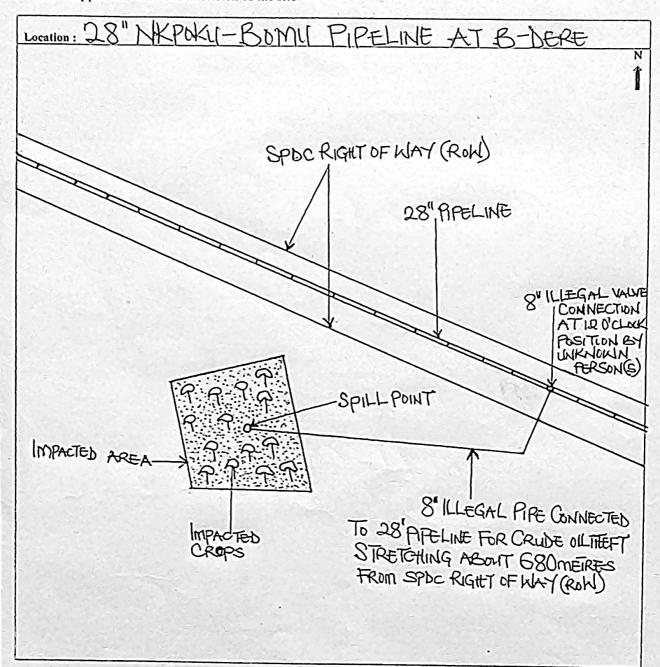
f. Appendix 1: Overview sketch of the slte

E. GRAPHIC DESCRIPTION OF LEAK POINT (while detailed description of the leak point should be contained in the leak report, or view sketch of the site should be added as a should be contained.
The leak report on view sketch of the site should be added as appendix 1). A SECTION OF 28" NKOKI-
BOMY PIPELINE AT B-DERE STOWING 8 ILLEGAL VALVE CONN-
ECTION AT 12 O'CLICK POSITION BY YNKNOWN PERSONG)
8" ILLEGAL 8" PIPE CONNECTED
8" ILLEGAL TO ILLEGAL VALVE AT ID O'CLOCK POSITION BY INKNOWN PERSONS)
28" \ ( ) [28"
28" NKPOKU - BOMU MF
Distribution of copies (Arnite (Asset Owner) Pank (DPR); Green (NOSDRA) Yellow (State Ministry of Environment)  Rage 3 of 8

Northing NaGS 84	
S/N	Northing LATITUDE	Easting LENGITUDE
1.	4.679438	7.261001
2.	4.679111	7.261105
3.	4.678883	7.260875
4.	4.679158	7.260635
1.00		
	COORDINATES OF 8" 1	LEGAL CONNECTION LINE TO
		PELLIE BY WIKHOWN PERSON
Ŀ	4.679347	7.266598
2.	4-678391	7-265259
٤٠	4-67910	7.260816
	THEFT POINT (	LOORD INATE
1-	4.679347	7.266598
		0
	• 77	
	3 75 7 2 7 7 7 7 7 7 7 7 7 7 7 7 7 7 7 7
