JOINT INVESTIGATION REPORT

INCIDENT NO: 2637568 JIV report S/N: 0519

1. Fountain Incident Number: 2637568 2. Type of incident* OIL SPILL
3. Name of Location: 28" NKPOKU - BOMU PIPELINE
4. Name of nearest community ELELENWO 5. State: RIVERS 6. LGA OBIO/AKPOR
7. Production Facility/Installation THE SHELL PETROLEUM DEVELOPMENT COMPANY
8. Asset Owner/Hub THE SHELL PETROLEUM DEVELOPMENT COMPANY OF NIGERIA LTD (SPDC) / PIPELINE

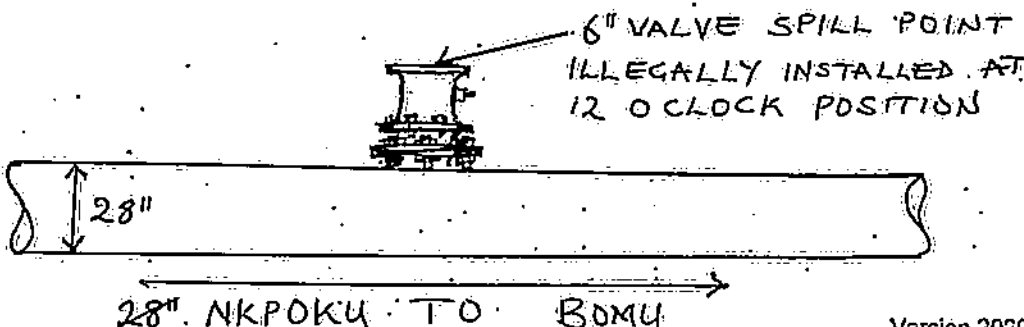
E. GRAPHIC DESCRIPTION OF LEAK POINT (while detailed description of the leak point should be contained in the leak report, overview sketch of the site should be added as appendix 1)

A SECTION OF 28" NKPOKU - BOMU PIPELINE AT ELELENUO SHOWING A 6" VALVE CRUDE OIL THEFT POINT, INSTALLED AT 12 O' CLOCK POSITION BY UNKNOWN PERSONS.

BLIND FLANGING
