JOINT INVESTIGATION REPORT

INCIDENT NO: 2639025 JIV report S/N:

1. Fountain Incident Number: 2639025 2. Type of incident* OIL SPILL
3. Name of Location 4" IMORIVER WELL 55S FLOWLINE
4. Name of nearest community IGIRUKWU 5. State: ABIA 6. LGA UKWA WEST
7. Production Facility/Installation FLOWLINE
8. Asset Owner/Hub THE SHELL PETROLEUM DEVELOPMENT COMPANY OF NIGERIA LTD. (SPDC) LAND EAST HUB

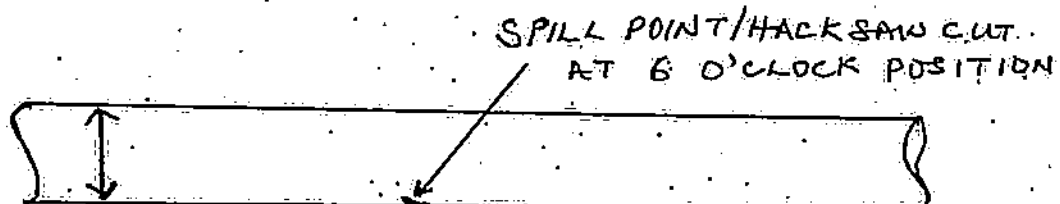
| <input type="checkbox"/> Smooth round-edge hole | <input type="checkbox"/> Rough-edge hole | <input checked="" type="checkbox"/> Hack saw cut |

E. GRAPHIC DESCRIPTION OF LEAK POINT (while detailed description of the leak point should be contained in the leak report, overview sketch of the site should be added as appendix 1) A SECTION OF IMO RIVER WELL 55 S FLOWLINE AT IGIRIUKWU SHOWING HACK SAW CUT SPILL POINT AT 6 O'CLOCK POSITION BY UNKNOWN PERSON(S)
