JOINT INVESTIGATION REPORT

INCIDENT NO: 2641594 JIV report S/N: 0535

1. Fountain Incident Number: 2641594 2. Type of incident* OIL SPILL
3. Name of Location 4" BONNY WELL 10S FLOWLINE RISER AT OLOMA
4. Name of nearest community OLOMA 5. State: RIVERS 6. LGA BONNY
7. Production Facility/Installation WELL HEAD RISER
8. Asset Owner/Hub THE SHELL PETROLEUM DEVELOPMENT COMPANY OF NIGERIA

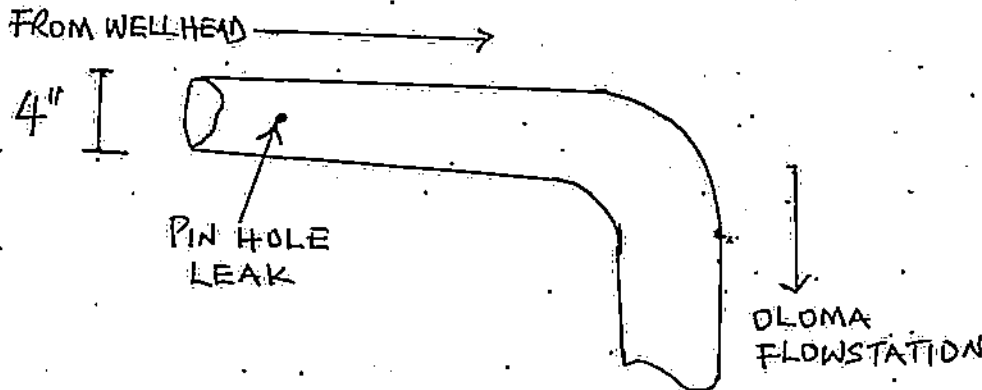
| <input checked="" type="checkbox"/> Others (specify) <u>PIN HOLE (CORROSION)</u> | | |

SKETCH SHOWING SECTION OF 4" BONNY WELL 10S FLOWLINE RISER
