Overview: Part of spill impact on 20'' Kolocreek-Rumuekpe Pipeline at Aminigboko . Picture was taken during Joint Investigation 30th May 2020.

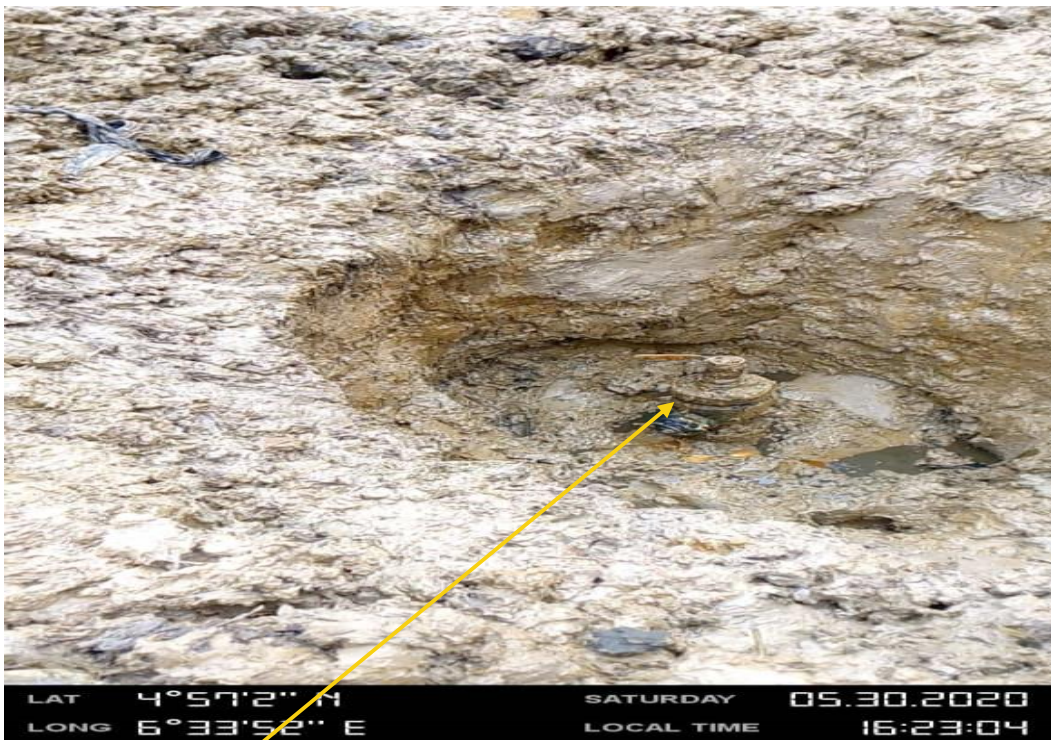
Close-up: 3'' ball valve illegal connection installed at 12 o'clock position on 20'' Kolocreek - Rumuekpe Pipeline at Aminigboko . Picture was taken during Joint Investigation 30th May 2020.

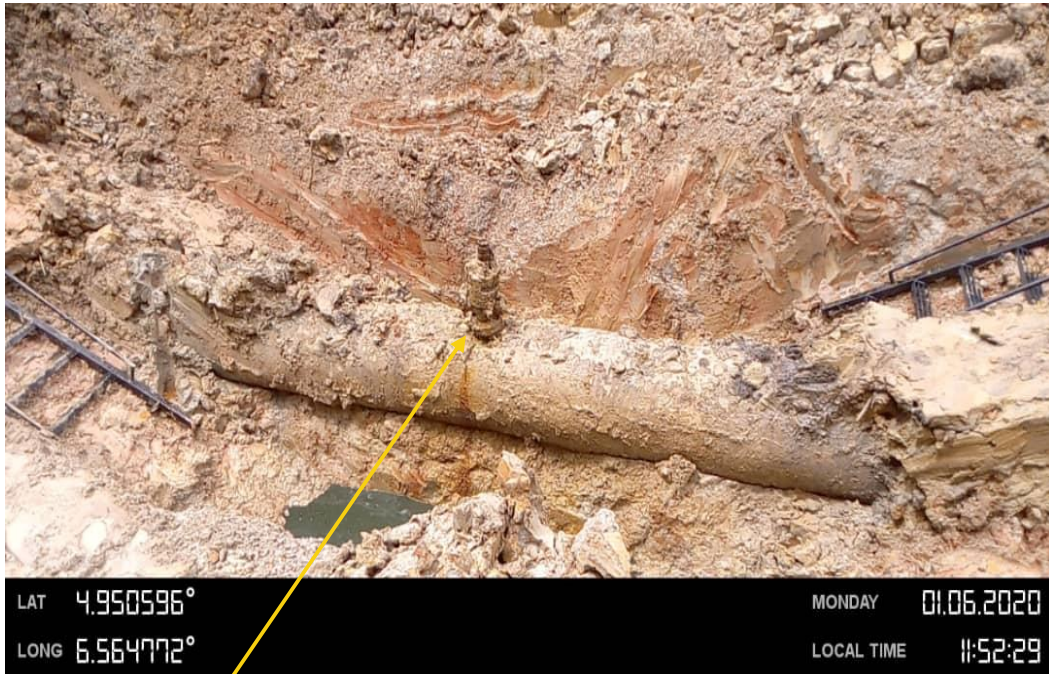
Close-up: 3" ball valve illegal connection installed at 12 o'clock position on 20" Kolocreek - Rumuekpe Pipeline at Aminigboko . Picture was taken on 1st June 2020.
