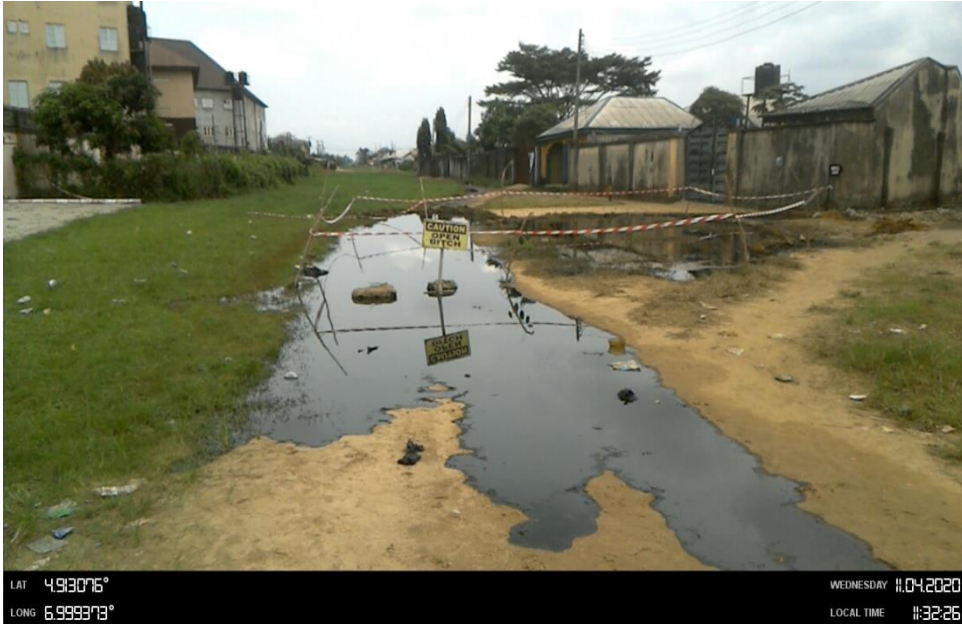
Overview: Part of spill impact on 8" Agbada 2 - Nkpoku Pipeline at Rukpokwu. Picture was taken during Joint Investigation on 4th November 2020.

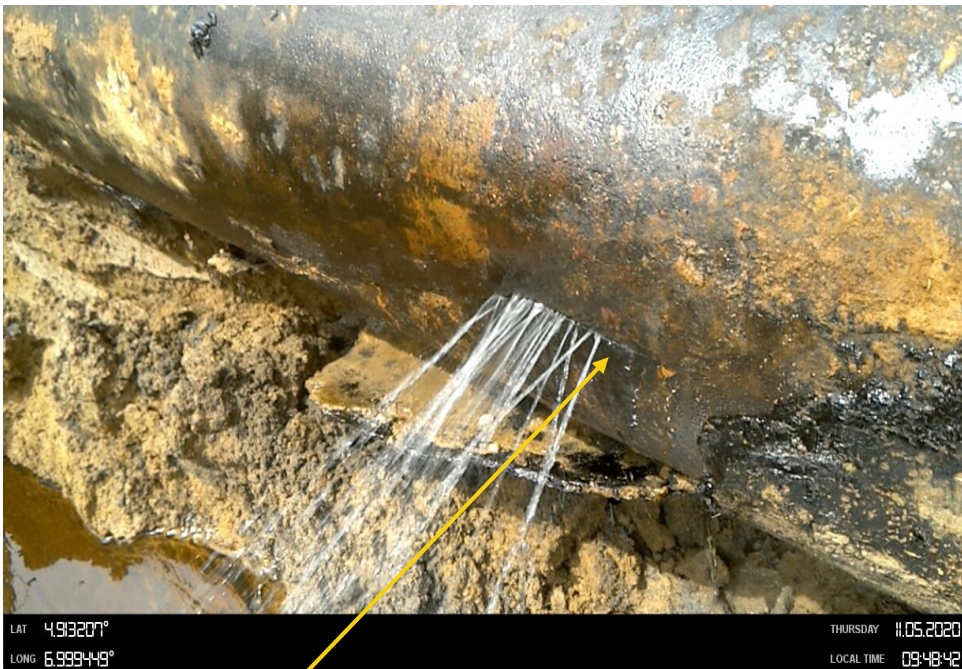
Close-up: Inward dent / Tear at 9 o'clock position on 8" Agbada 2 - Nkpoku Pipeline at Rukpokwu . Picture was taken during Joint Investigation on 5th November 2020.
