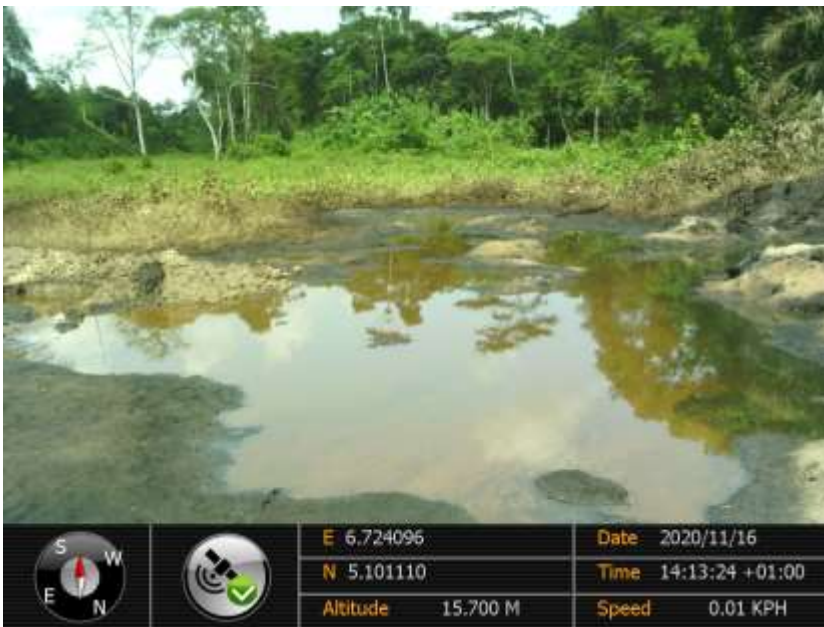
Overview: Part of spill impact on 18inch Assa Rumuekpe Pipeline at Akpabu. Picture was taken during Joint Investigation on 16th November 2020.

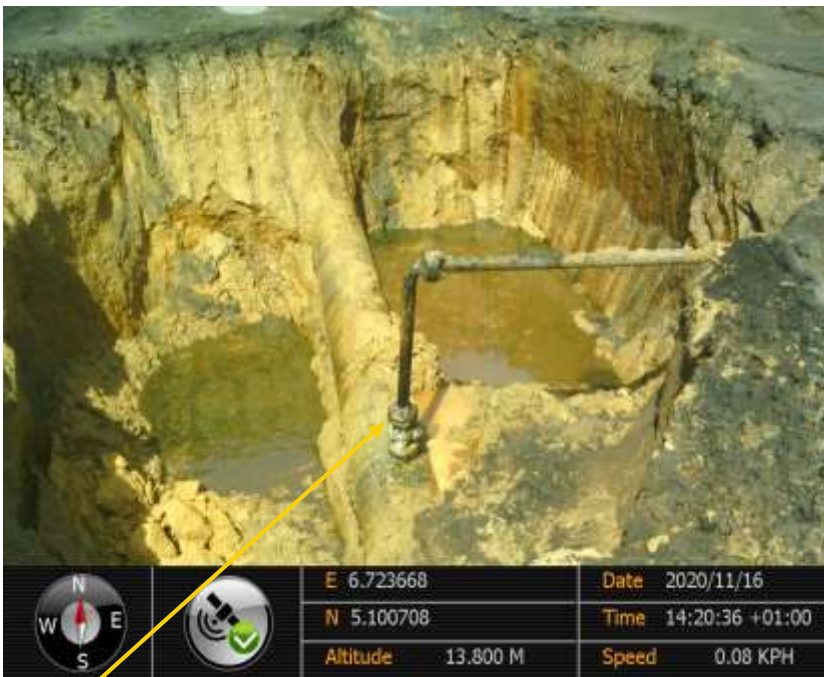
Close-up: 2inch valve illegal connection installed at 12 o'clock position on 18inch Assa Rumuekpe Pipeline at Akpabu. Picture was taken during Joint Investigation on 16th November 2020.
