JOINT INVESTIGATION REPORT

INCIDENT NO: 2789262 JIV report S/N: 0622

1. Fountain Incident Number: 2789262 2. Type of incident* OIL SPILL
3. Name of Location 12" IMOR 2 - OGARE PIPELINE
4. Name of nearest community UMUOLOLO 5. State: ABIA 6. LGA UKWA WEST
7. Production Facility/Installation PIPELINE
8. Asset Owner/Hub THE SHELL PETROLEUM DEVELOPMENT COMPANY OF NIGERIA LIMITED (SPDC)/PIPELINE

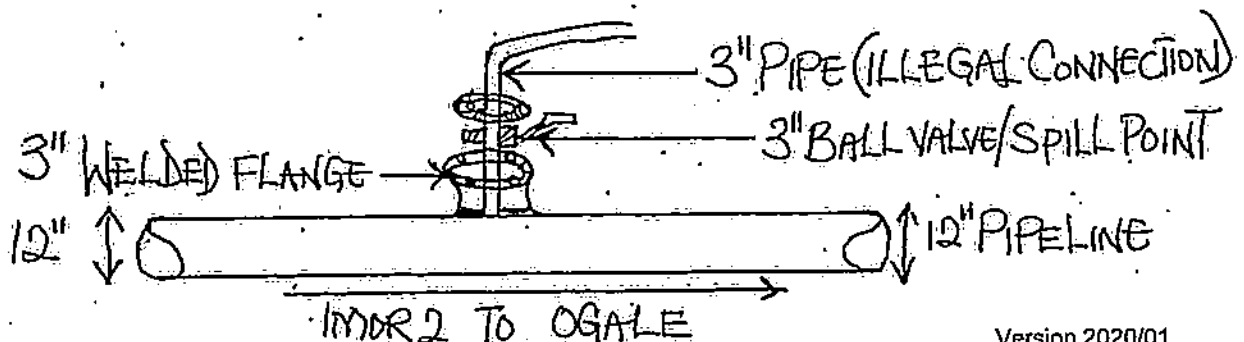
E. GRAPHIC DESCRIPTION OF LEAK POINT (while detailed description of the leak point should be contained in the leak report, overview sketch of the site should be added as appendix 1)

| <input checked="" type="checkbox"/> Crude oil theft (illegal bunkering) point, | <input type="checkbox"/> Saver-pit over flow | <input type="checkbox"/> Third party tampering with Clamp |

- Third party interference (Sabotage ; crude theft ; Line theft ; Accidental 3rd party damage
 Operational Others (including Mystery spills) _____

A SECTION OF 12" IMDR 2 - OGALE PIPELINE AT UMUOLOLO SHOWING A 3" VALVE CONNECTION WELDED ON A FLANGE AT 12 O' CLOCK POSITION BY UNKNOWN PERSON(S).

REPAIR BY CLAMPING
