Overview: Part of spill impact on 16inch NunRiver – Kolocreek Pipeline at Otugwe. Picture was taken during Joint Investigation on 22nd November 2020.

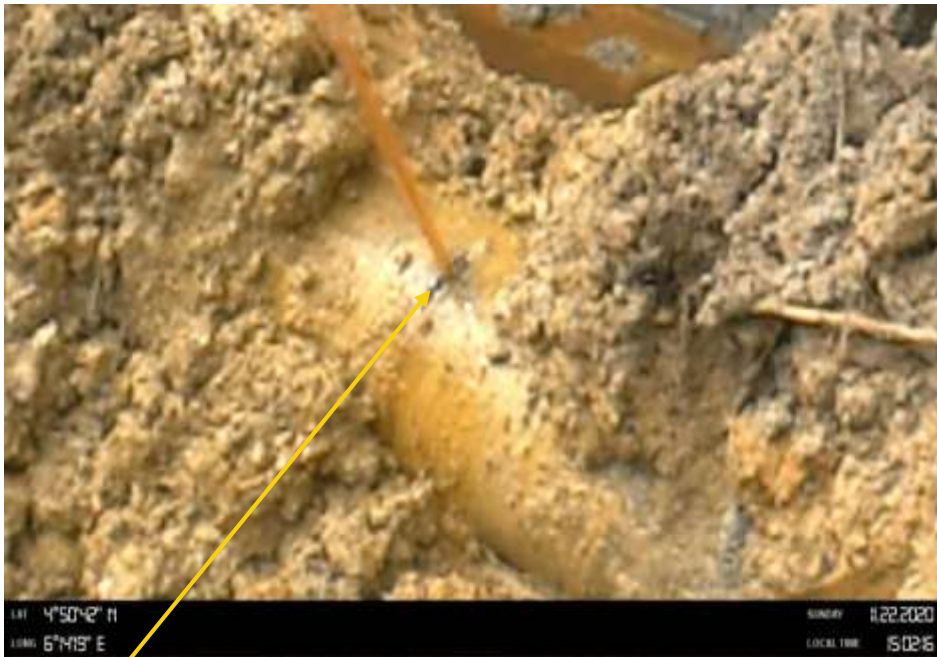
Close-up: Point 1: 2nos hacksaw cut 75m apart at 12 o'clock on 16inch NunRiver – Kolocreek Pipeline at Otugwe. Picture was taken during Joint Investigation on 22nd November 2020.

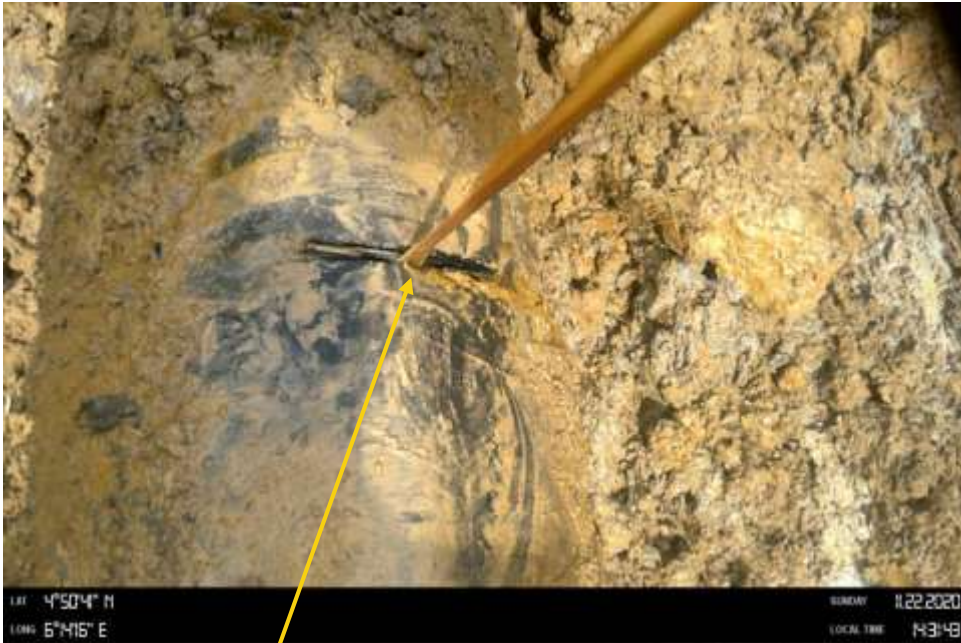
Close-up: Point 2: 2nos hacksaw cut 75m apart at 12 o'clock on 16inch NunRiver – Kolocreek Pipeline at Otugwe. Picture was taken during Joint Investigation on 22nd November 2020.
