JOINT INVESTIGATION REPORT

INCIDENT NO: 2781593 JIV report S/N:

1. Fountain Incident Number: 2781593 2. Type of incident* OIL SPILL
3. Name of Location 12" IMORI - OGALE PIPELINE
4. Name of nearest community IMUOLOLO 5. State: ABIA 6. LGA UKWA WEST
7. Production Facility/Installation PIPELINE
8. Asset Owner/Hub THE SHELL PETROLEUM DEVELOPMENT COMPANY OF NIGERIA LIMITED (SPDC) / PIPELINE

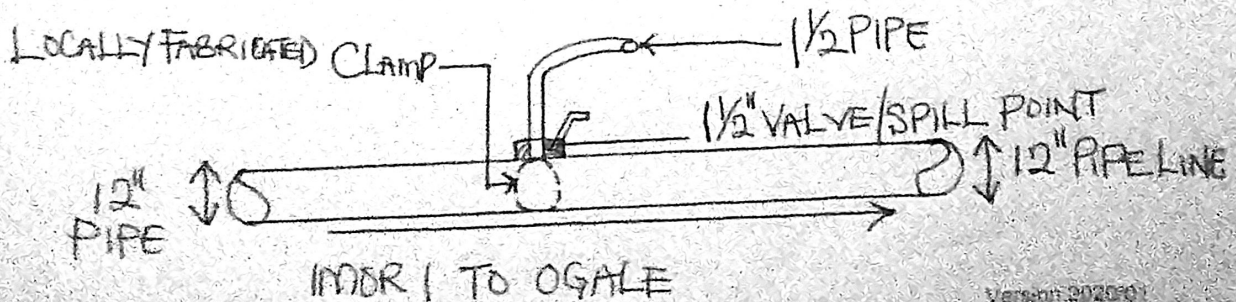
E. GRAPHIC DESCRIPTION OF LEAK POINT (while detailed description of the leak point should be contained in the leak report, overview sketch of the site should be added as appendix 1)

| <input checked="" type="checkbox"/> Crude oil theft (illegal bunkering) point, | <input type="checkbox"/> Saver-pit over flow | <input type="checkbox"/> Third party tampering with Clamp |

A SECTION OF 12" IMDR 1 - OGALE AT UMUDOLO SHOWING A LOCAL CLAMP FITTED WITH 1/2" VALVE INSTALLED AT 12 O'CLOCK POSITION BY UNKNOWN PERSON(S)

CLAMPING ONGOING
