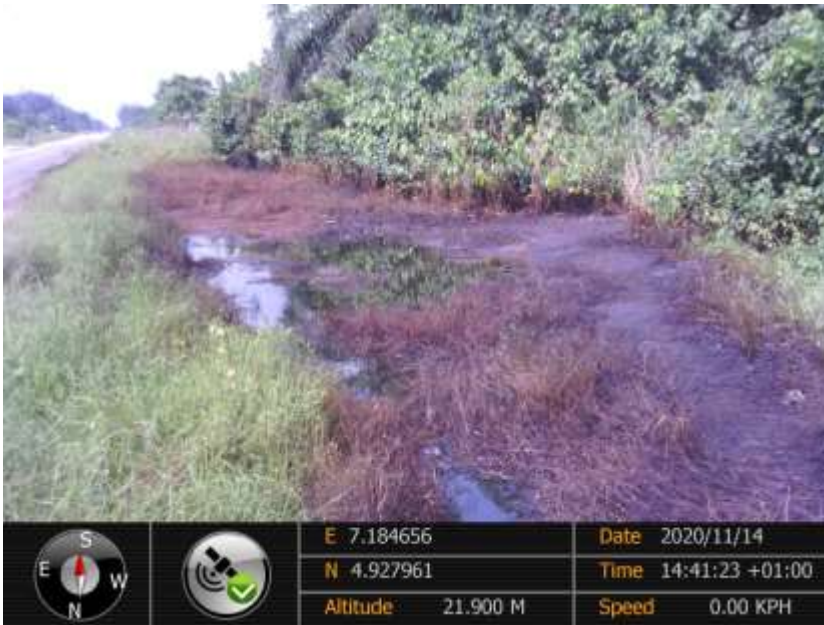
Overview: Part of spill impact on 12inch Imoriver 1 - Ogale Pipeline at Okohia.
 Picture was taken during Joint Investigation on 14th November 2020

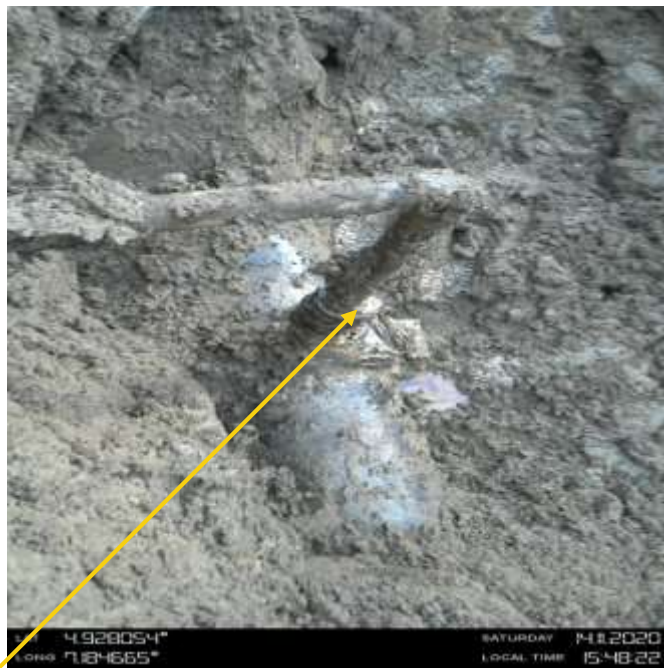
Close-up: Locally fitted clamp with 1.5inch valve installed at 12 o'clock position on 12inch Imoriver 1 - Ogale Pipeline at Okohia.
 Picture was taken during Joint Investigation on 14th November 2020.
