JOINT INVESTIGATION REPORT

INCIDENT NO: 2793484 JIV report S/N: 0626

1. Fountain Incident Number: 2793484 2. Type of incident* OIL SPILL
3. Name of Location 12th (MOR 1 - OGALE PIPELINE
4. Name of nearest community ~~OGALE~~ ~~OGALE~~ ~~OGALE~~ 5. State: RIVERS 6. LGA ELEME
7. Production Facility/Installation PIPELINE
8. Asset Owner/Hub THE SHELL PETROLEUM DEVELOPMENT COMPANY OF NIGERIA LIMITED (SPDC) PIPELINE

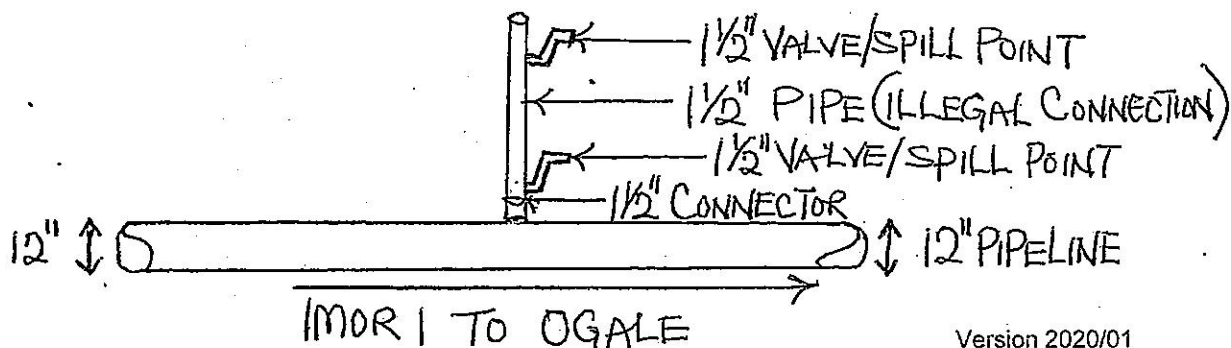
E. GRAPHIC DESCRIPTION OF LEAK POINT (while detailed description of the leak point should be contained in the leak report, overview sketch of the site should be added as appendix 1)

A SECTION OF 12" IMOR 1-OGALE PIPELINE AT KONKOM SHOWING 1/2" PIPE FITTED WITH 2 NOS OF 1/2" VALVES INSTALLED AT 12 O'CLOCK POSITION BY UNKNOWN PERSON(S).

REPAIR BY CLAMPING
