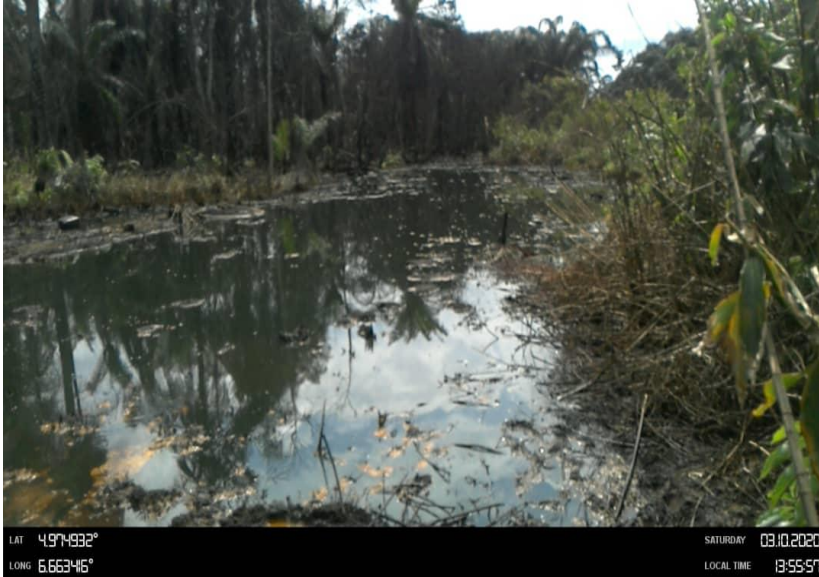
Overview: Part of spill impact on 20'' Kolocreek –Rumuekpe Pipeline at Ihuowo. Picture was taken during Joint Investigation on 3rd October 2020.

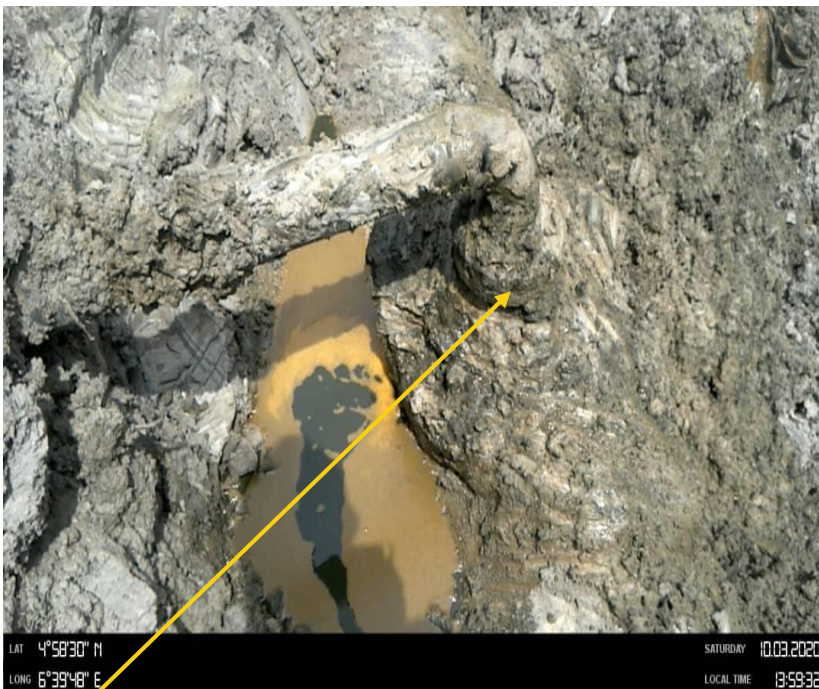
Close-up: 3'' illegal valve with a concrete cast attached to a 3'' galvanized pipe at 12 o'clock position on 20'' Kolocreek –Rumuekpe Pipeline at Ihuowo. Picture was taken during Joint Investigation on 3rd October 2020.
