# JOINT INVESTIGATION REPORT

INCIDENT NO: 2750348 JIV report S/N:

1. Fountain Incident Number: 2750348 2. Type of incident\* OIL SPILL  
3. Name of Location 20" KOLOCREEK - RUMUEKPE PIPELINE  
4. Name of nearest community IHUOWO 5. State: RIVERS 6. LGA AHOADA-EAST  
7. Production Facility/Installation OIL PIPELINE  
8. Asset Owner/Hub THE SHELL PETROLEUM DEVELOPMENT COMPANY OF NIGERIA LIMITED (SPDC)/PIPELINE

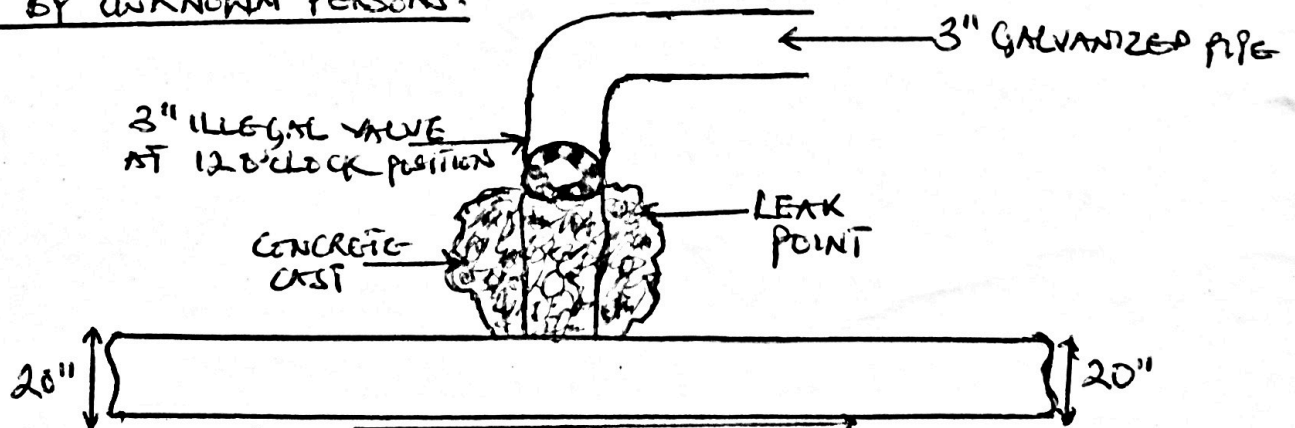
**E. GRAPHIC DESCRIPTION OF LEAK POINT** (while detailed description of the leak point should be contained in the leak report, overview sketch of the site should be added as appendix 1) A SECTION OF 20" KOLDCREEK-RUMUETKE PIPELINE AT HUCHO SHOWING A 3" ILLEGAL VALVE WITH A CONCRETE CAST ATTACHED TO A 3" GALVANIZED PIPE AT 12 O'CLOCK POSITION BY UNKNOWN PERSONS.

FROM KOLDCREEK-RUMUETKE PIPELINE

| <input checked="" type="checkbox"/> Failed Weld-on illegal hot tap valve | <input type="checkbox"/> Failed Clamp, | <input type="checkbox"/> Missing Pipeline/Flowline |
| <input checked="" type="checkbox"/> Crude oil theft (illegal bunkering) point, | <input type="checkbox"/> Saver-pit over flow | <input type="checkbox"/> Third party tampering with Clamp |
