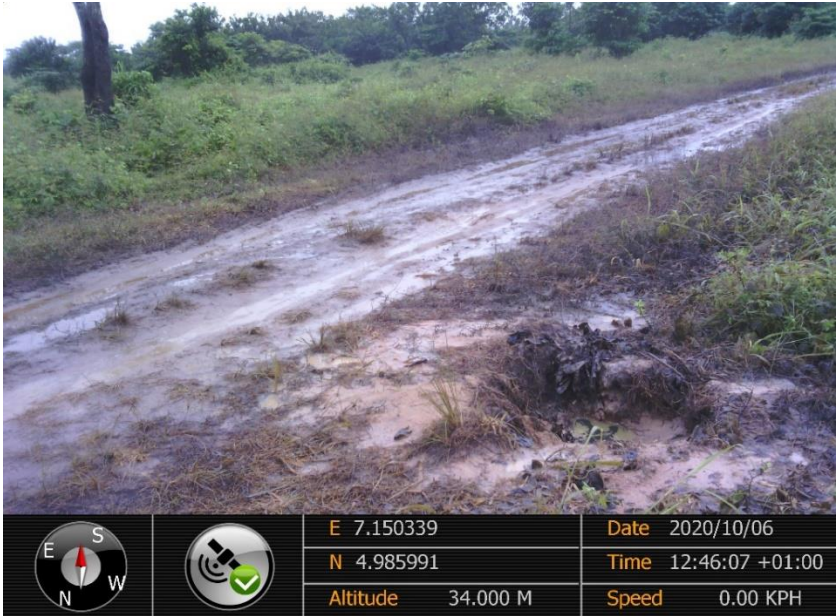
Overview: Part of spill impact on 8'' Nkali ImoRiver 2 Pipeline at Nkali. Picture was taken during Joint Investigation on 6th October 2020.

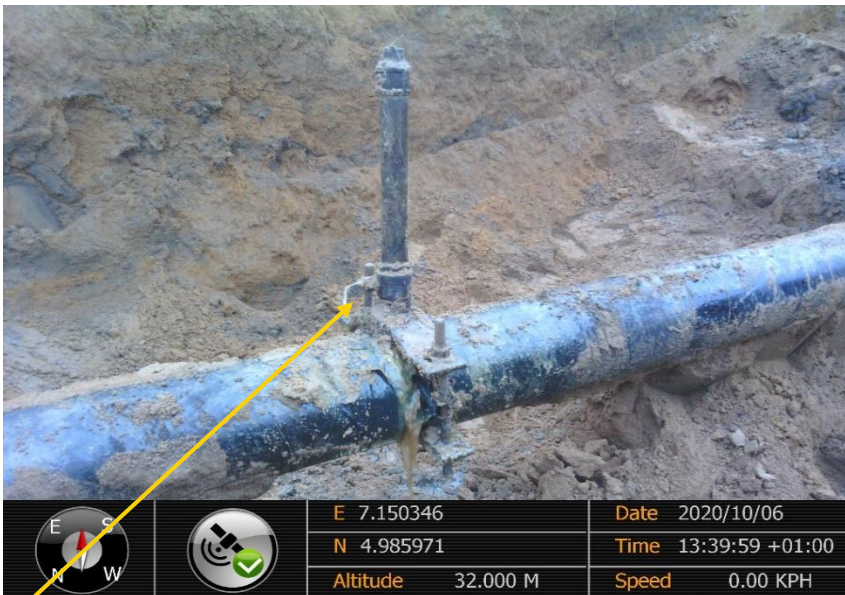
Close-up: 1.5'' locally fabricated clamp with 1.5'' valve installed at 12 o'clock position on 8'' Nkali ImoRiver2 Pipeline at Nkali.
Picture was taken during Joint Investigation on 6th October 2020.
