# JOINT INVESTIGATION REPORT

INCIDENT NO: 2751724 JIV report S/N: 0578

1. Fountain Incident Number: 2751724 2. Type of incident\* OIL SPILL  
3. Name of Location 8<sup>th</sup> NKALI - IMOR 2 PIPELINE (DL)  
4. Name of nearest community NKALI 5. State: RIVERS 6. LGA ETCHIE  
7. Production Facility/Installation CRUDE OIL PIPELINE  
8. Asset Owner/Hub THE SHELL PETROLEUM DEVELOPMENT COMPANY OF NIGERIA LIMITED (SPDC)/PIPELINE

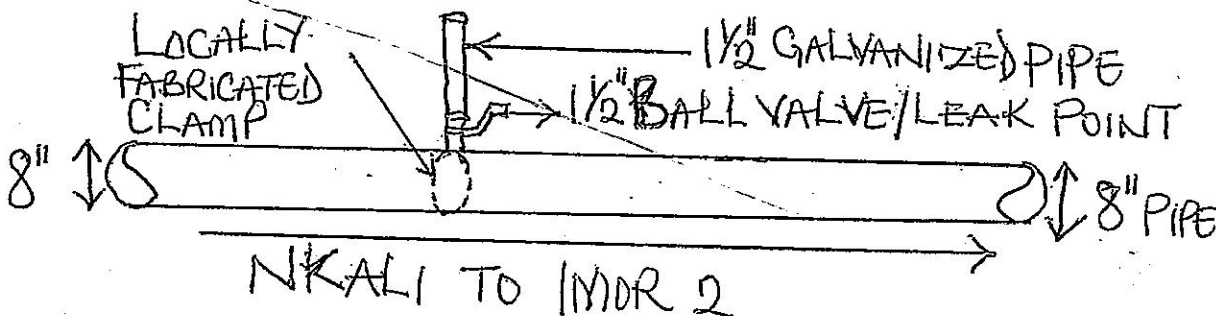
**E. GRAPHIC DESCRIPTION OF LEAK POINT** (while detailed description of the leak point should be contained in the leak report, overview sketch of the site should be added as appendix 1) A SECTION OF 8" NKALI-IMOR 2 PIPELINE AT NKALI SHOWING 1/2" LOCALLY FABRICATED CLAMP WITH 1/2" VALVE INSTALLED AT 12 O'CLOCK POSITION BY UNKNOWN PERSON(S).

CLAMPING ON-GOING
