**Overview:** Part of spill impact on 12" Imo River2 - Ogale Pipeline at Igiriukwu isietitioha Owaza .  
Picture was taken during Joint Investigation on 1st November 2020.

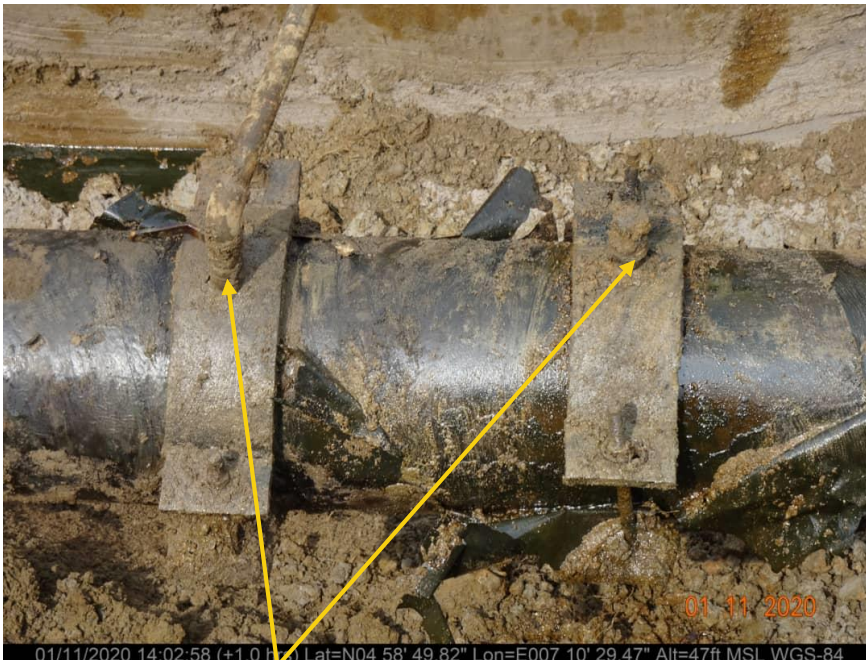
01/11/2020 14:02:58 (+1.0 hrs) Lat=N04 58' 49.82" Lon=E007 10' 29.47" Alt=47ft MSL WGS-84

**Close-up:** 2nos crude oil theft points installed at 12 o'clock position on 12" Imo River2 - Ogale Pipeline at Igiriukwu isietitioha Owaza . Picture was taken during Joint Investigation on 1st November 2020.
