JOINT INVESTIGATION REPORT

INCIDENT NO: 2765638 JIV report S/N: 0730

1. Fountain Incident Number: 2765638 2. Type of incident* OIL SPILL
3. Name of Location 4" YOKRI WELL 127 T FLOWLINE
4. Name of nearest community YOKRI 5. State: DELTA 6. LGA BURUTU
7. Production Facility/Installation FLOW LINE
8. Asset Owner/Hub THE SHELL PETROLEUM DEVELOPMENT COMPANY NIGERIA LIMITED / WEST ASSET.

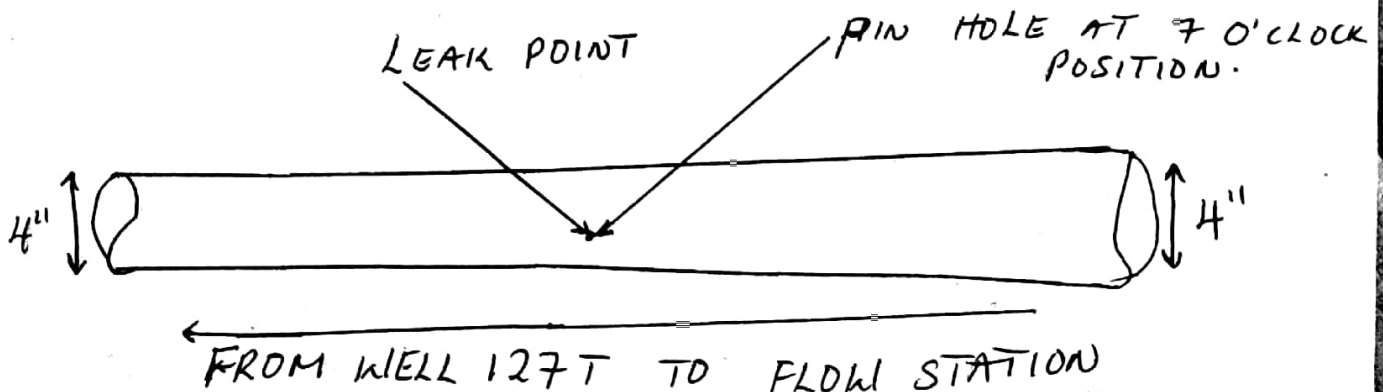
| <input checked="" type="checkbox"/> Others (specify) <u>PIN HOLE</u> | | |

A SECTION OF 4" ^{YOKRI} WELL 127 T FLOW LINE AT YOKRI SHOWING A PIN HOLE AT 7 O'CLOCK POSITION.

NDT APPLICABLE
