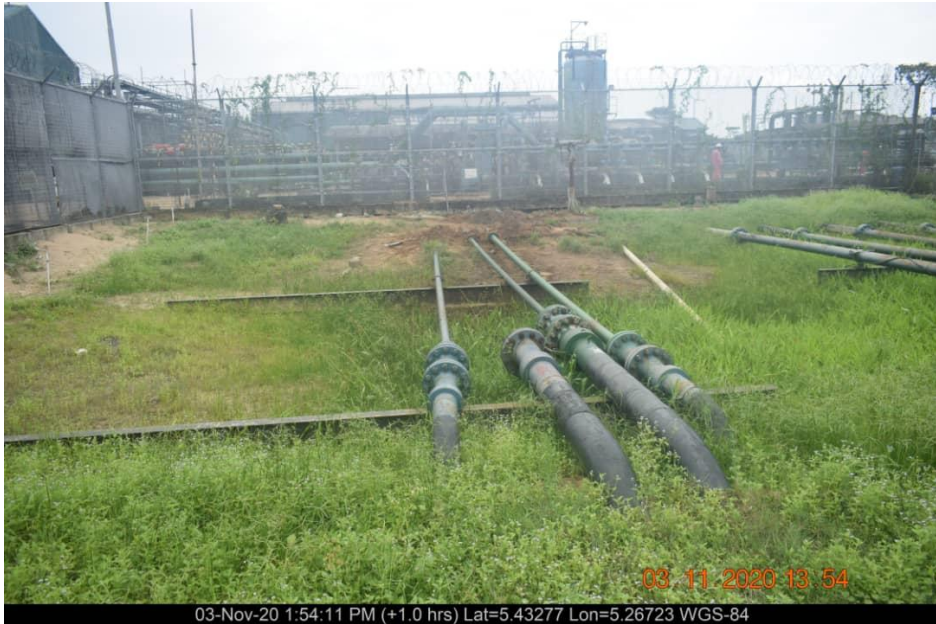
Overview: Part of spill impact on 4" Yokri Well 27 T Flowline at Yokri . Picture was taken during Joint Investigation on 3rd November 2020.

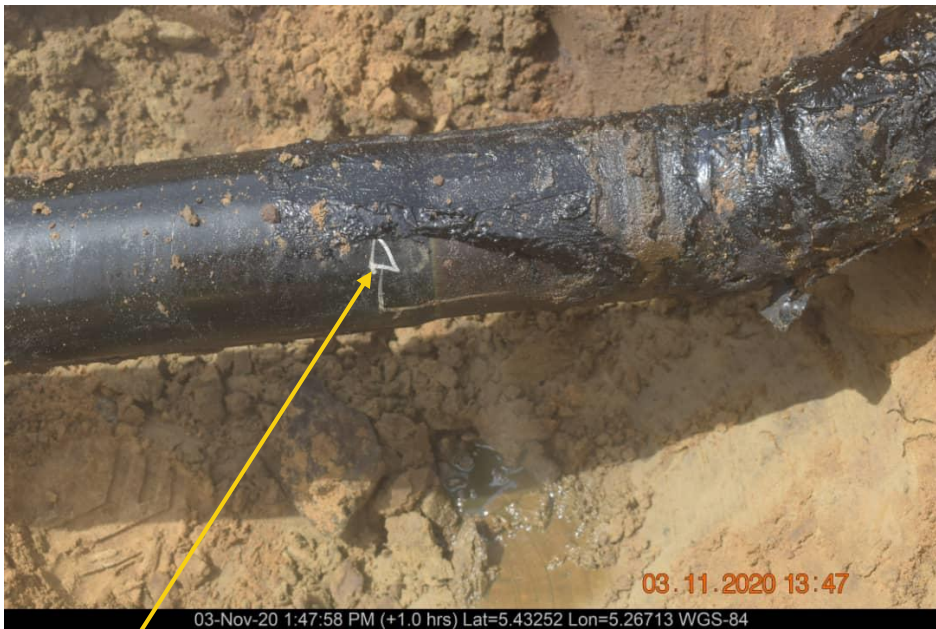
Close-up: Pin hole at 7 o'clock position on 4" Yokri Well 27 T Flowline at Yokri . Picture was taken during Joint Investigation on 3rd November 2020.
