JOINT INVESTIGATION REPORT

INCIDENT NO: 2774990 JIV report S/N: 0613

1. Fountain Incident Number: 2774990 2. Type of incident* OIL SPILL
3. Name of Location 3rd NUN RIVER WELL U/LIMA FLOWLINE
4. Name of nearest community OPOROMA 5. State: BAYELSA 6. LGA SOUTHERN NAW
7. Production Facility/Installation FLOWLINE
8. Asset Owner/Hub THE SHELL PETROLEUM DEVELOPMENT COMPANY LIMITED (SPDC) / CENTRAL HUB

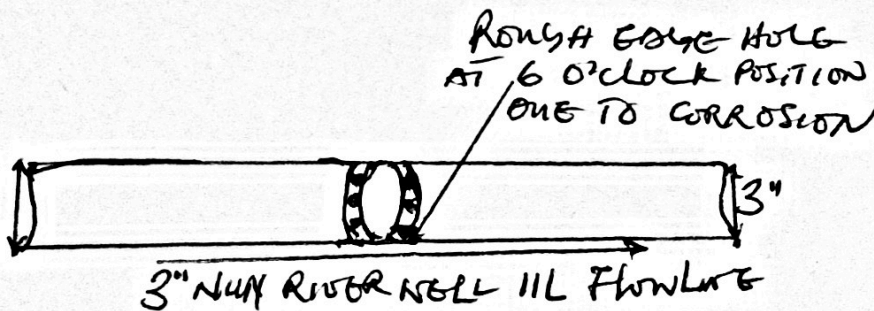
E. GRAPHIC DESCRIPTION OF LEAK POINT (while detailed description of the leak point should be contained in the leak report, overview sketch of the site should be added as appendix 1)

A SECTION OF 3" NUN RIVER WELL 11L FLOWLINE AT OPERAMA SHOWING A ROUGH-EDGE HOLE AT 6 O'CLOCK POSITION DUE TO CORROSION
