Overview: Part of spill impact on 6inch Escravos Well 13s Flowline at Ogidegben
Picture was taken during Joint Investigation on 16th November 2020.

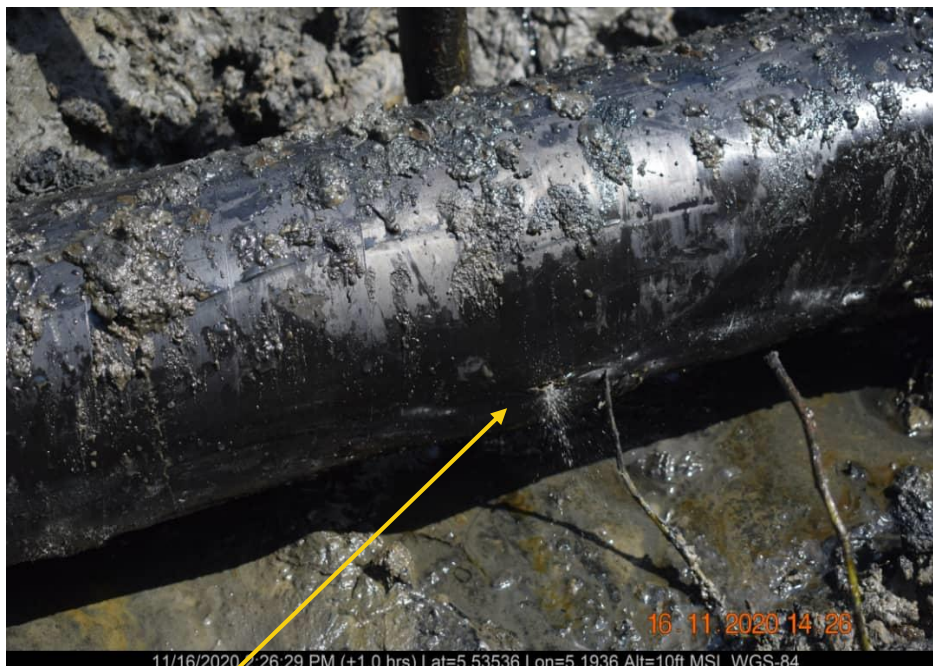
11/16/2020 2:26:29 PM (+1.0 hrs) Lat=5.53536 Lon=5.1936 Alt=10ft MSL WGS-84

Close-up: Tear at 3 o'clock position on 6inch Escravos Well 13s Flowline at Ogidegben.
Picture was taken during Joint Investigation on 16th November 2020.
