# JOINT INVESTIGATION REPORT

INCIDENT NO: 2725266 JIV report S/N:

1. Fountain Incident Number: 2725266 2. Type of incident\* OIL SPILL  
3. Name of Location 28" NIKPOKU - BOMU PIPELINE  
4. Name of nearest community EJAMAH 5. State: RIVERS 6. LGA ELEME  
7. Production Facility/Installation CRUDE OIL PIPELINE  
8. Asset Owner/Hub THE SHELL PETROLEUM DEVELOPMENT COMPANY  
OF NIGERIA LIMITED / PIPELINE

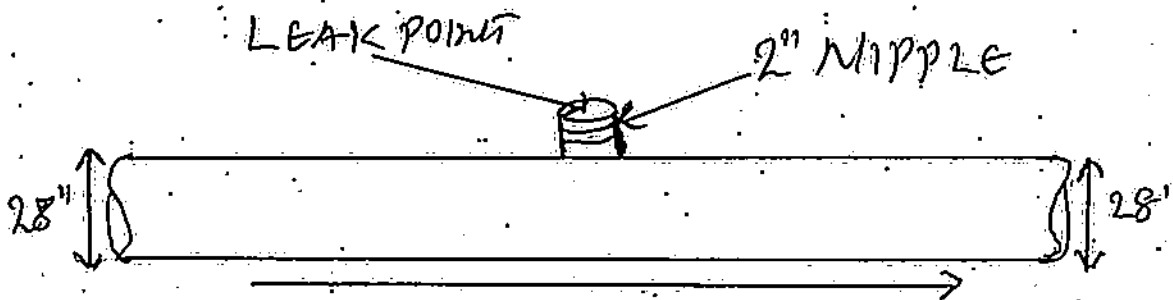
E. GRAPHIC DESCRIPTION OF LEAK POINT (while detailed description of the leak point should be contained in the leak report, overview sketch of the site should be added as appendix 1)

SECTION OF 28" NIKPOKU - BOMU PIPELINE AT ETAMAH SHOWING CRUDE OIL THEFT POINT INSTALLED AT 12 O'CLOCK POSITION BY UNKNOWN PERSON(S).

FROM NIKPOKU TO BOMU

REPAIR WAS DONE BY CLAMPING
