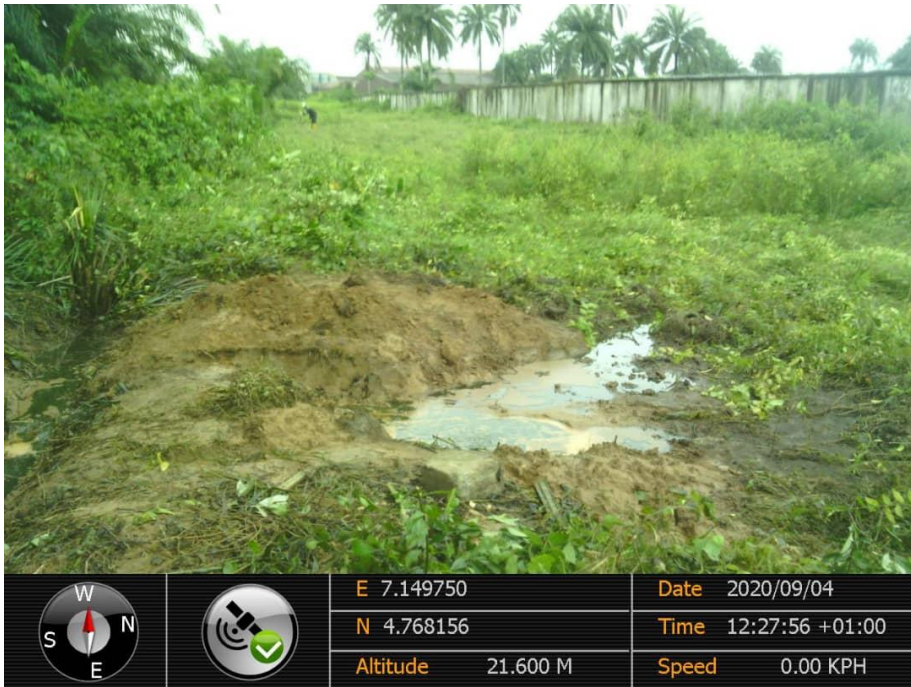
Overview: Part of spill impact on 28" Nkpoku - Bomu Pipeline at Ejamah. Picture was taken during Joint Investigation on 4th September 2020.

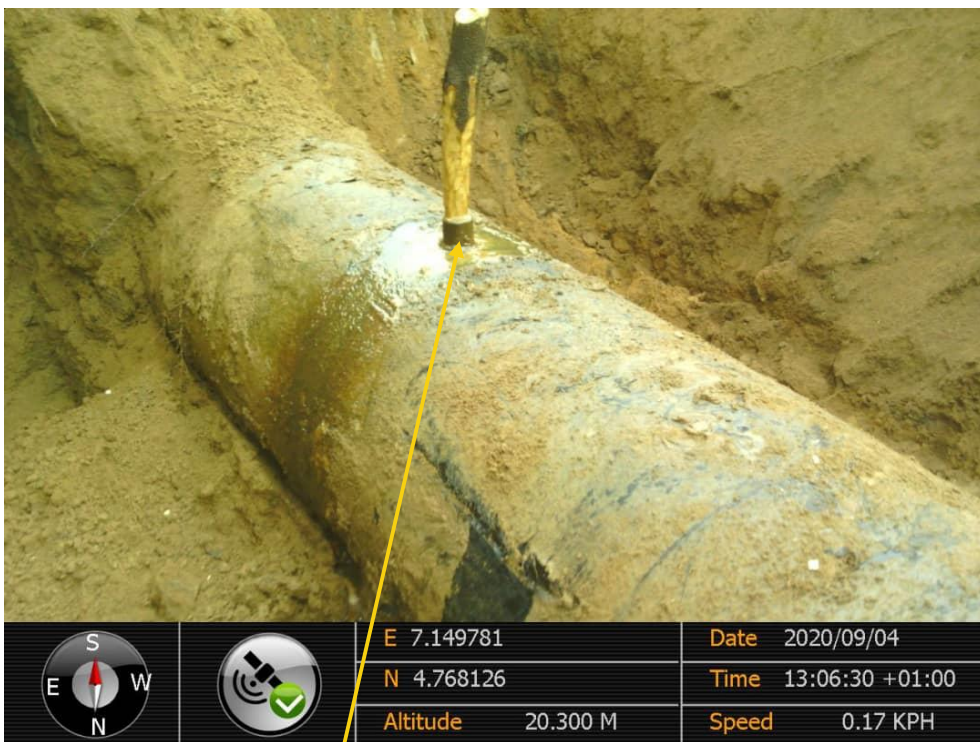
Close-up: Plugged crude oil theft point installed at 12 o'clock position on 28" Nkpoku - Bomu Pipeline at Ejamah . Picture was taken during Joint Investigation on 4th September 2020.
