Overview: Part of spill impact on Otamiri Well 7S Flowline at Umuechem
Picture was taken during Joint Investigation on 11th September 2020.

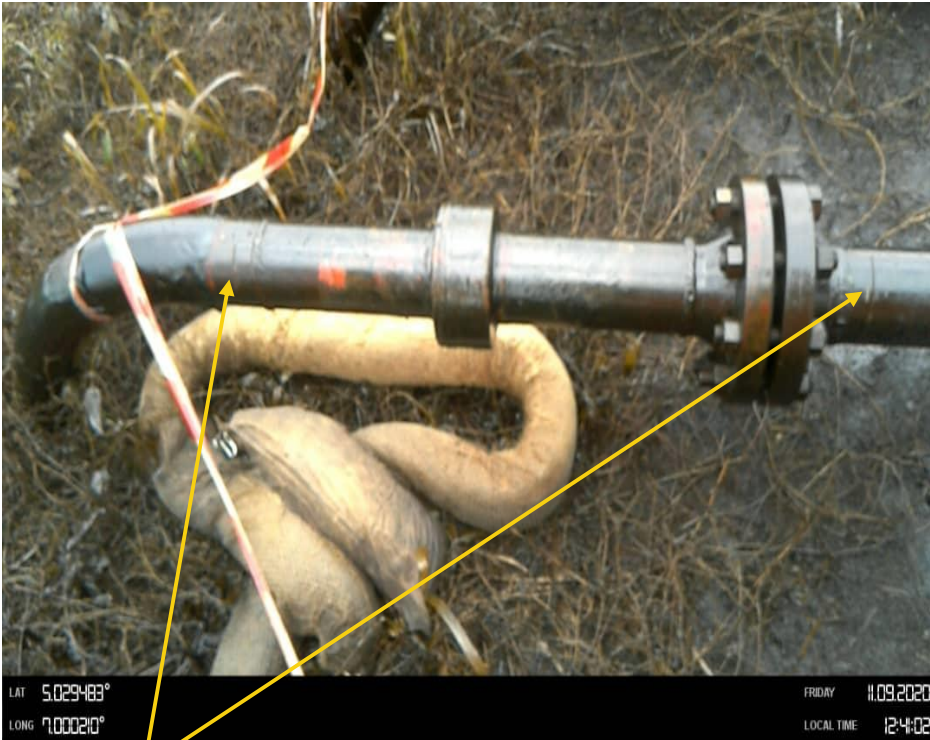
Close-up: Hacksaw cuts of 1.2m apart all at 11 o'clock position on Otamiri Well 7S Flowline at Umuechem. Picture was taken during Joint Investigation on 11th September 2020.
