# JOINT INVESTIGATION REPORT

INCIDENT NO: 2729184 JIV report S/N:

1. Fountain Incident Number: 2729184 2. Type of incident\* OIL SPILL  
3. Name of Location OTAMIRI WELL 7S FLOWLINE  
4. Name of nearest community UMUECHEM 5. State: RIVERS 6. LGA ETCHE  
7. Production Facility/Installation OIL FLOWLINE  
8. Asset Owner/Hub THE SHELL PETROLEUM DEVELOPMENT COMPANY OF NIGERIA LIMITED (SPDC)/LAND EAST HUB

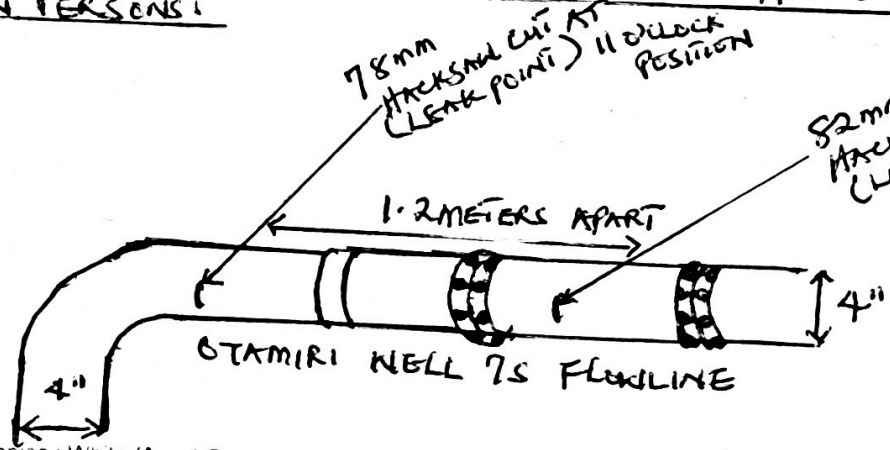
**E. GRAPHIC DESCRIPTION OF LEAK POINT** (while detailed description of the leak point should be continued in the leak report, overview sketch of the site should be added as appendix 1) A SECTION OF 4" STAMIRI WELL 7'S FLOWLINE AT UMUECHEM SHOWING A 72mm AND 82mm HACKSAW CUT OF 1.2 METERS APART ALL AT 11 O'CLOCK POSITION DONE BY UNKNOWN PERSONS!
