INCIDENT NO: 2730588 JIV report S/N:

- 1. Fountain Incident Number: 2730588 2. Type of incident* OIL SPILL
- 3. Name of Location IMO RIVER 1 WELL 44S FLOWLINE
- 4. Name of nearest community IGIRIUKWU/ISI-ETITIONA 5. State: ABIA 6. LGA UKWA WEST
- 7. Production Facility/Installation OIL FLOWLINE
- 8. Asset Owner/Hub THE SHELL PETROLEUM DEVELOPMENT COMPANY OF NIGERIA LIMITED (SPDC) / LAND EAST HUB

JOINT INVESTIGATION REPORT

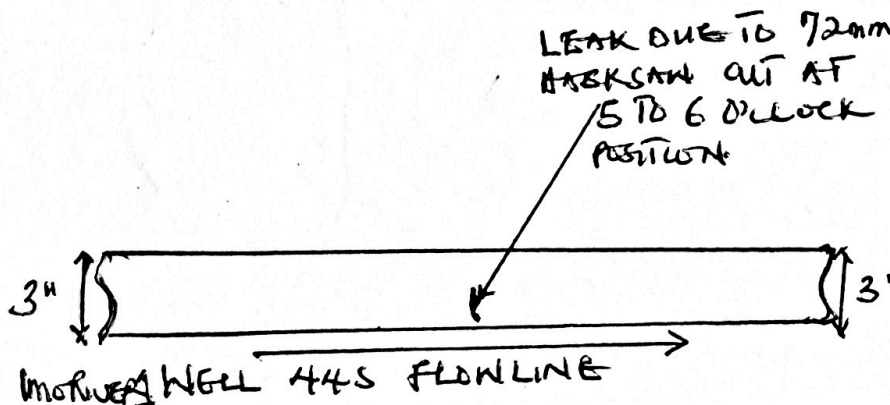
E. GRAPHIC DESCRIPTION OF LEAK POINT (while detailed description of the leak point should be contained in the leak report, overview sketch of the site should be added as appendix 1)

A SECTION OF IMO RIVER I WELL 445 FLOWLINE AT IKIRUKWU/ISI-ETITIONA SHOWING A 72mm HACK-SAW CUT AT 5 TO 6 O'CLOCK POSITION DONE BY UNKNOWN PERSONS.
